# Coos Bay Rail Link Bridge Condition Assessment

## Draft Report – Volume 3 of 3

**OREGON DEPARTMENT OF TRANSPORTATION  
RAIL DIVISION  
CORP BRIDGE 716.4**

**INSPECTION REPORT**

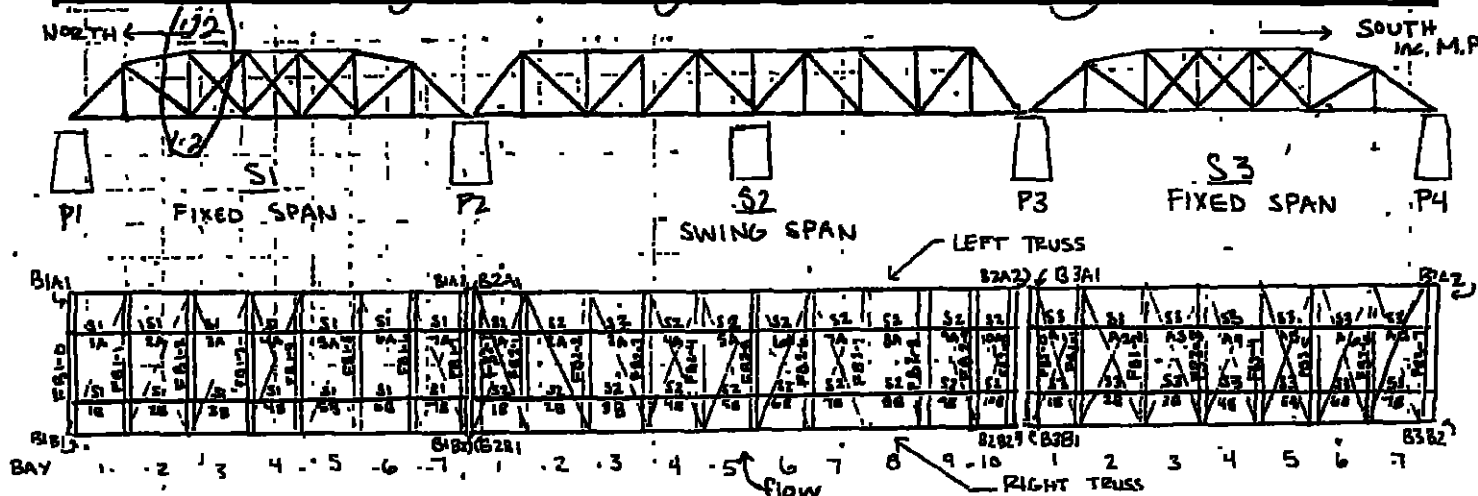
Location: Span (1) 2 3 Truss (1) R Member TC BC (MC) Bay: 2/3

| Member Name: | Joint | Element | Joint | Remarks: 50% LOSS OF LAGS (TYP.) |

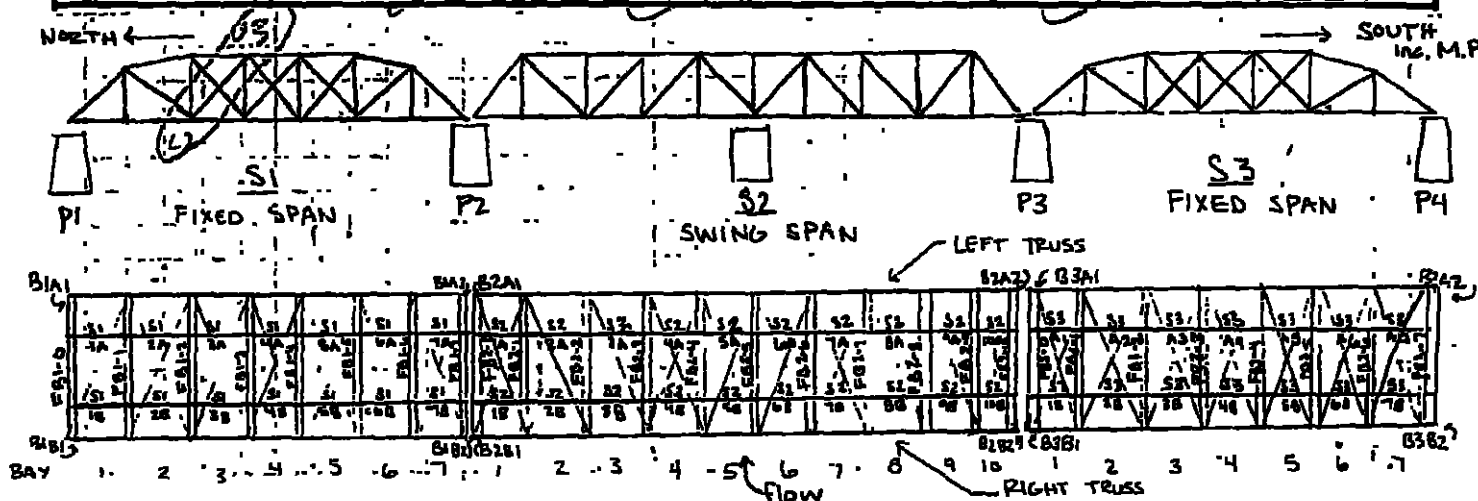
Location: Span 1/2 3 Truss L R Member TC BC/MC Bay: 3

| Member Name: | Joint | Element | Joint | Remarks: SEVERE PIT THROUST |

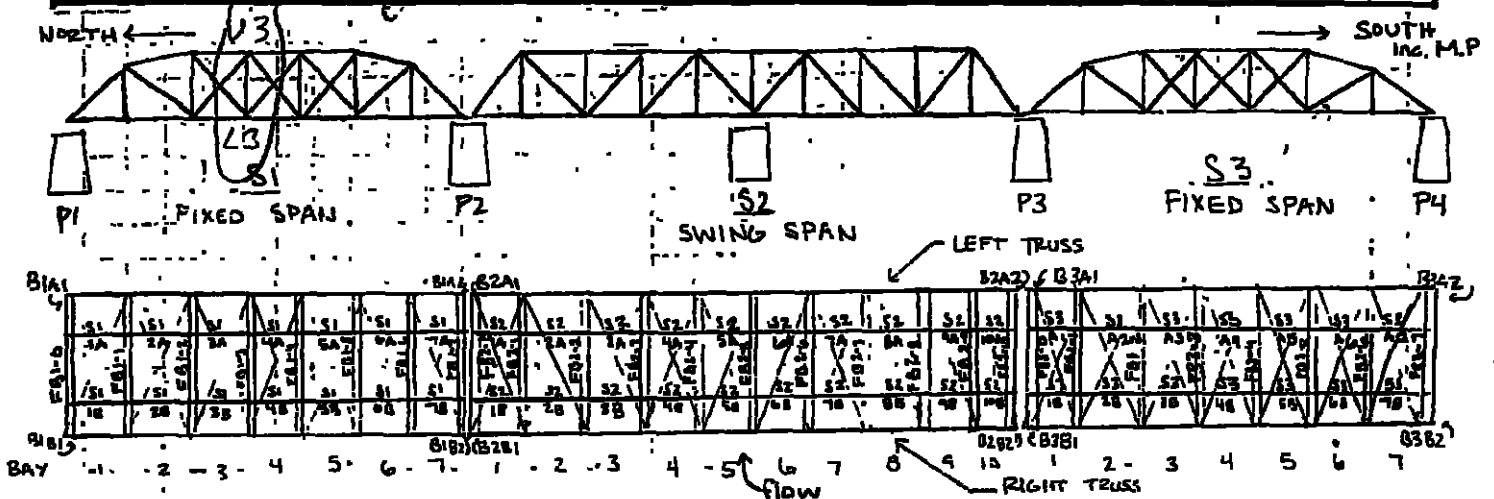
Bay: 3/4

| Member Name: | Joint | Element | Joint | Remarks: LACING 50% GONE |

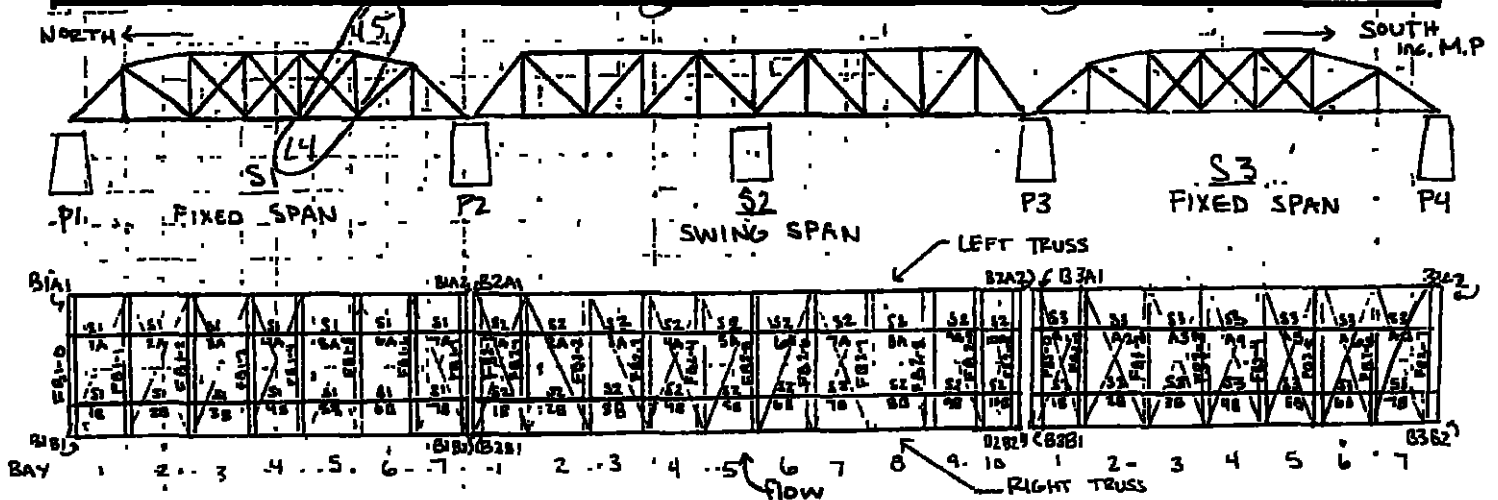
Location: Span 2 3 Truss L R Member TC BC / MC Bay: S

| | Joint | Element | Joint | Remarks: <u>MOD. PIT</u> |
