**REPLY TO "MOTION TO PERMIT INSPECTION AND REPAIR  
OR, IN THE ALTERNATIVE, PETITION TO REOPEN  
DECISION IN ORDER TO PERMIT INSPECTION AND REPAIR"**

**ENGINEERING INSPECTION REPORT  
OF  
RAILROAD ASSETS**

**PYCO INDUSTRIES, INC. ALTERNATIVE 2  
STB FINANCE DOCKET 34890  
A PORTION OF TRACKAGE OWNED BY  
SOUTH PLAINS SWITCHING, LTD., CO.**

**July 23, 2007**

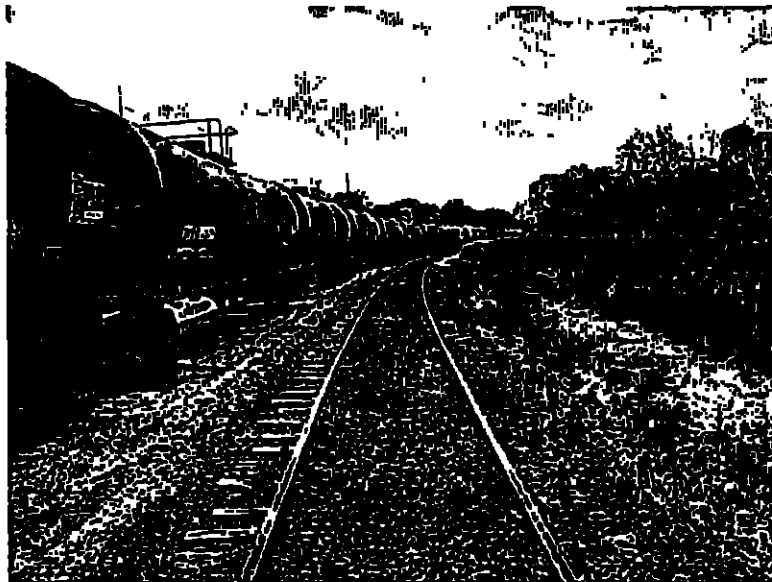
**East Side of BNSF Main Line  
Looking RR West on Center Line TEAM Track No 9298 (SAW Main Line) 85# Rail  
TEAM Track No. 9200 (90# Siding) is on the South Side of the Main Line**

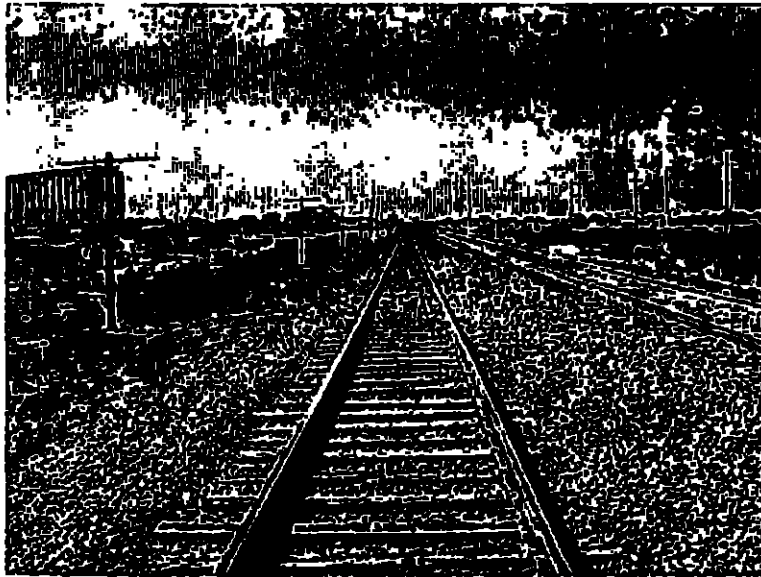
**July 18, 2006  
East Side of BNSF Main Line  
CLIC Track 0310 (90# Rail) Looking South towards Atteberry & Farmers Compress**

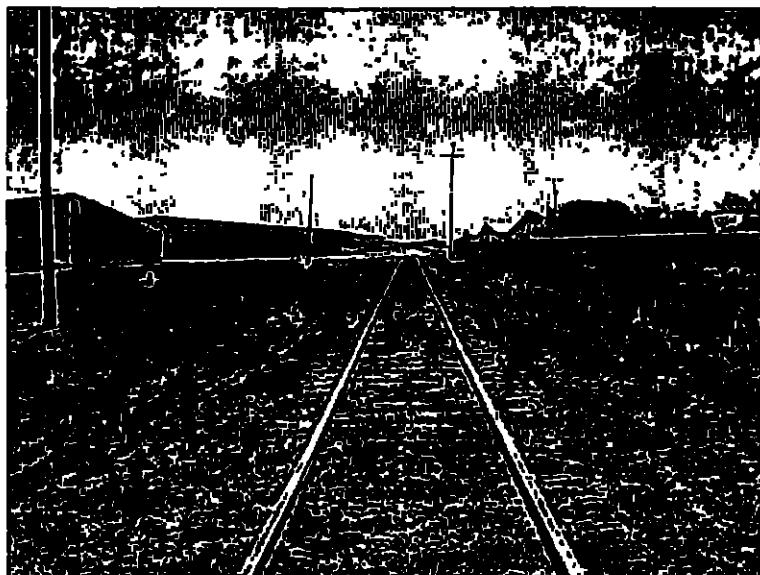
**CLIC Track 0310 (FWD ICC No 37) within Farmers Compress  
Looking Geographic East**

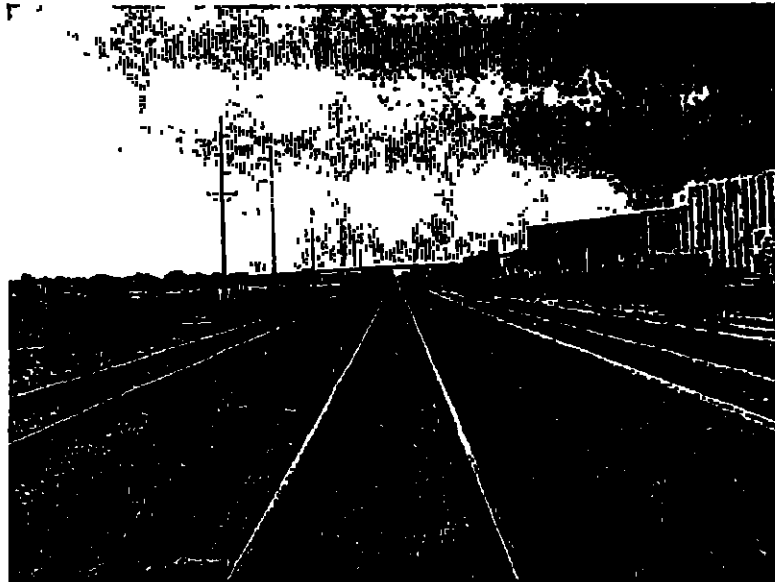
**July 23, 2007  
West Side of BNSF Main Line  
TEAM Track No. 9298 – SAW Main Line (Looking East from Jupiter Road)**
