# Coos Bay Rail Link Bridge Condition Assessment

## Draft Report – Volume 3 of 3

**OREGON DEPARTMENT OF TRANSPORTATION  
RAIL DIVISION  
CORP BRIDGE 716.4**

**INSPECTION REPORT**

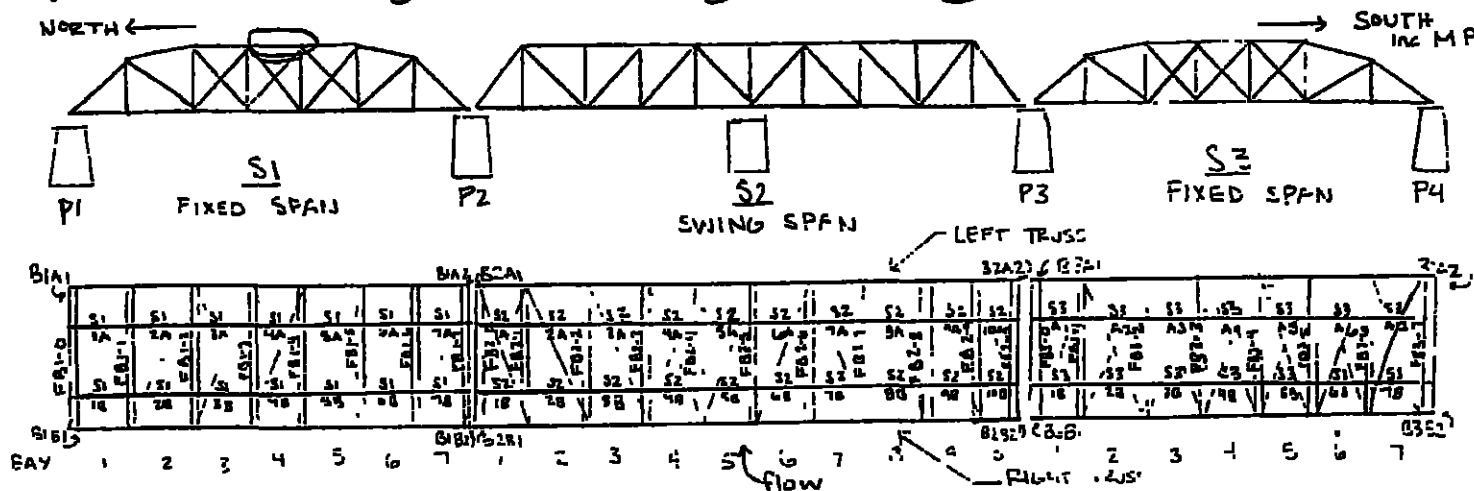
Location: Span (1) 2 3 Truss L (R) Member (TC) BC MC Bay 4

| | Joint | Element | Joint | Remarks: |
|---|---|---|---|---|
| Condition Rating: | 5 | 5 | 5 | |

NBI: 2 Condition: S Material Loss (%): 75

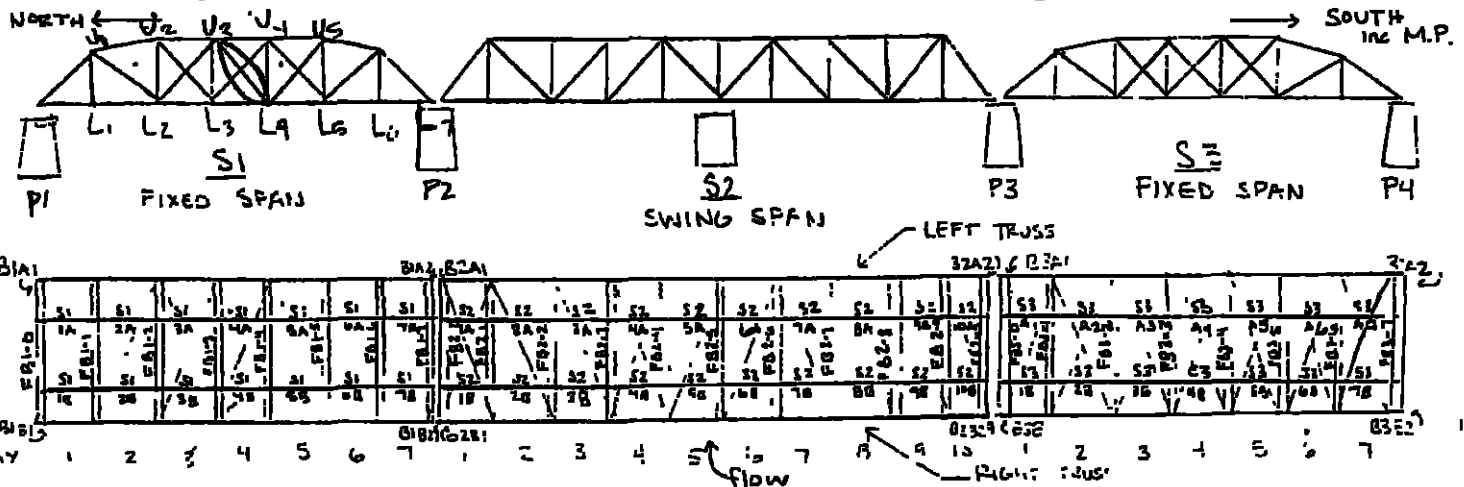
Member TC BC MC

| Member Name: | Joint | Element | Joint | Remarks: |
|---|---|---|---|---|
| Condition Rating: | 3 | 3 | 3 | L4 - 3/4" laminar rust rack not silver at |

Cross-Brace:  
NBI: 2 Condition: 5 Material Loss (%): 75%  
Remarks: holes in elements

General Comments/Recommendations:  
Top Vert is typical for entire bridge.

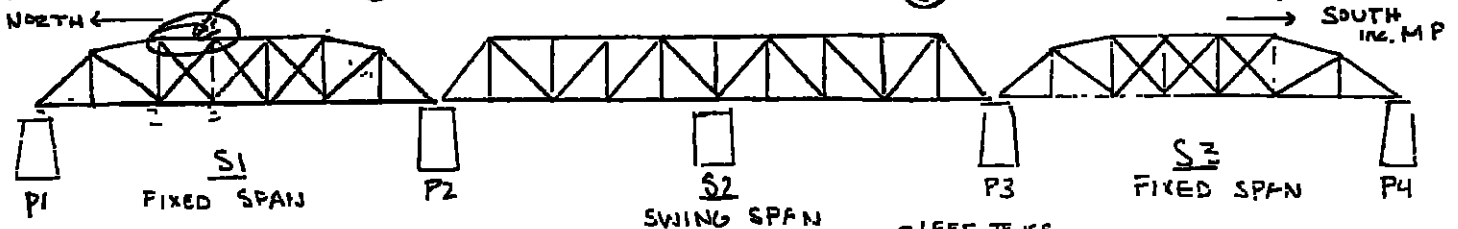
Location: Span (1/2) 3 Truss L (R) Member (TC) BC MC Bay. 3

| Member Name: | Joint | Element | Joint | Remarks: |
|---|---|---|---|---|
| Condition Rating: | 5 | 5 | 5 | |

| NBI: | 5 | Condition: | 5 |

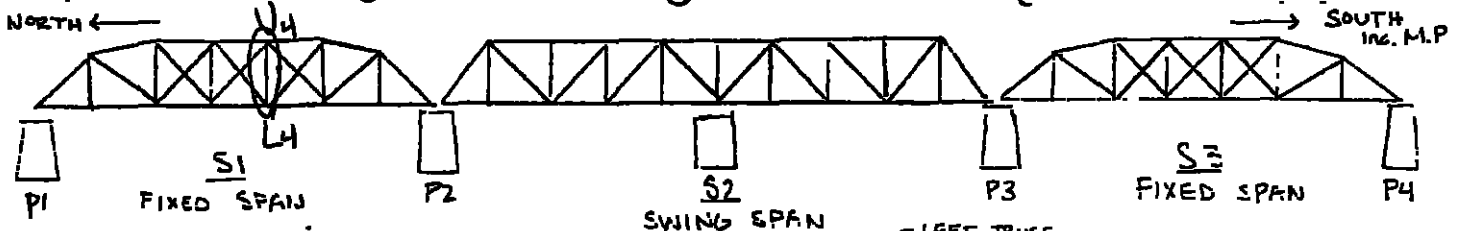
Location: Span (1) 2 3 Truss L (R) Member TC BC (MC) Bay:

| Member Name: | Joint | Element | Joint | Remarks: |
|---|---|---|---|---|
| Condition Rating: | 3 | 5 | 5 | |

| NBI: | 5 | Condition: | 5 | Material Loss (%): 75%* |

| NBI: | 4 | Condition: | 5 | Material Loss (%): 10% |

| NBI: | 5 | Condition: | 4 | Material Loss (%): pin 5% nut 10% |

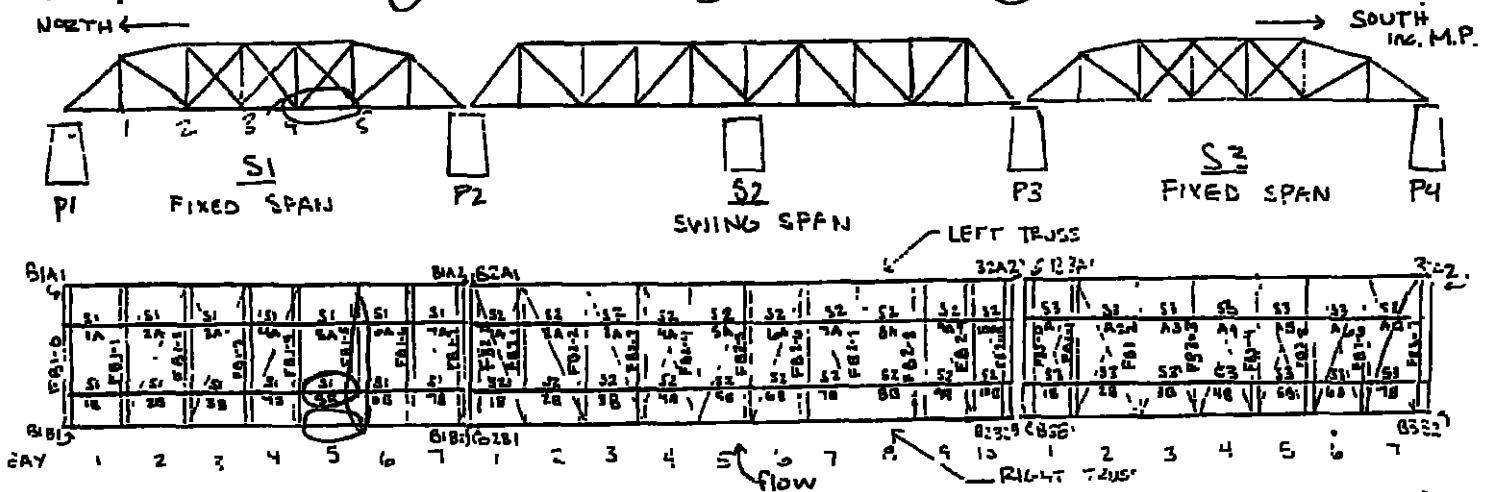
Location: Span (1) 2 3 Truss L (R) Member TC (BC) MC Bay: 5

| Member Name: | Joint | Element | Joint | Remarks: |
|---|---|---|---|---|
| Condition Rating: | 5 | 5 | | |

| NBI: <u>2</u> | Condition: <u>5</u> | Material Loss (%): <u>75%</u> |

| NBI: <u>4</u> | Condition: <u>5</u> | Material Loss (%): <u>40%</u> |
| Remarks: <u>delong. action loss of rivets etc. missing</u> | | |

| NBI: <u>3</u> | Condition: <u>5</u> | Material Loss (%): <u>see picture.</u> |

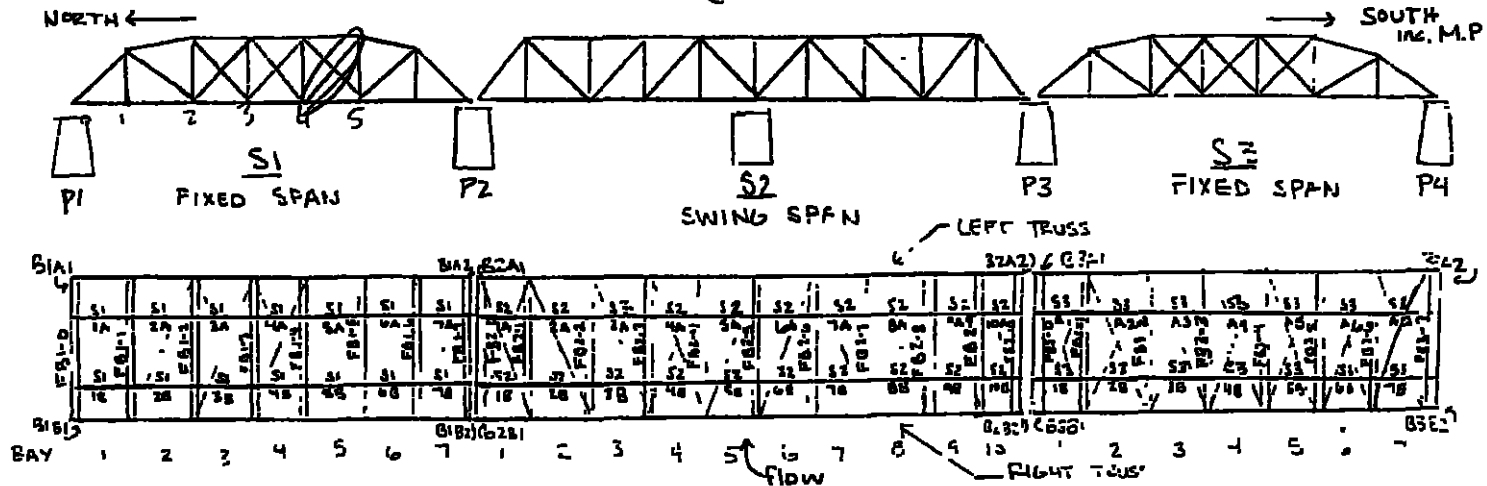
Location: Span (1) 2 3 Truss L (R) Member TC BC (MC) Bay: S

| Member Name: | Joint | Element | Joint | Remarks: |
|---|---|---|---|---|
| Condition Rating: | 5 | 4 | 5 | |

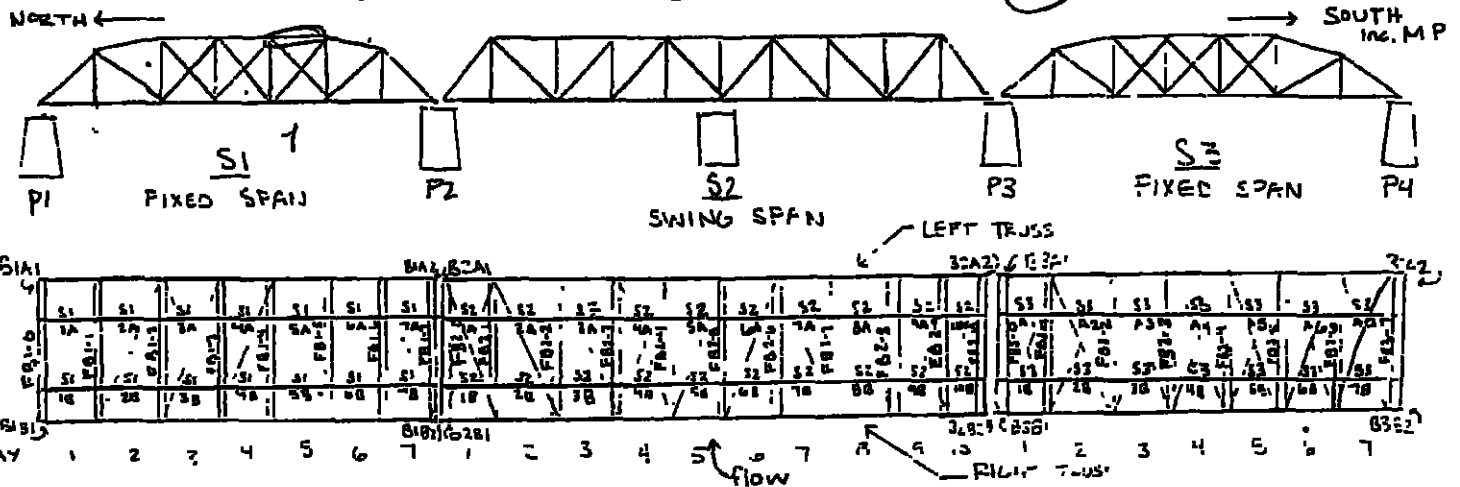
Location: Span (1) 2 3 Truss L R Member TC BC MC Bay: 5

| Member Name: | Joint | Element | Joint | Remarks: |
|---|---|---|---|---|
| Condition Rating: | <u>5</u> | <u>5</u> | <u>5</u> | |

| NBI: | <u>2</u> | Condition: | <u>5</u> | Material Loss (%): <u>75% *</u> |

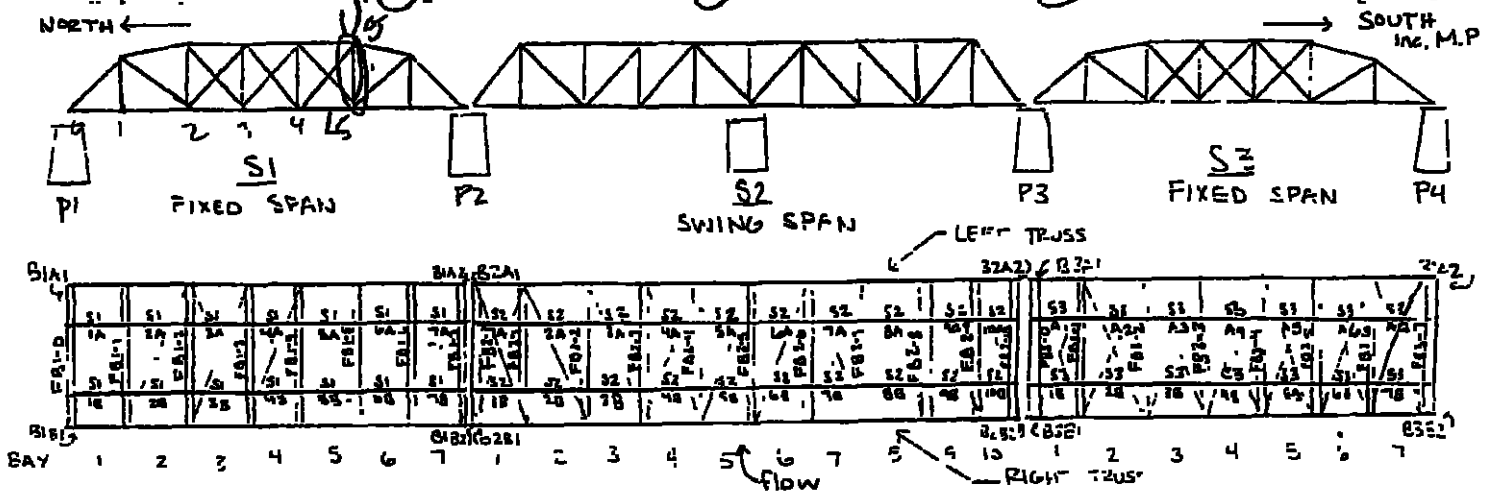
INSPECTED BY *Walt Arndt*DATE *9/13/08*WEATHER *70° Sunny*Location: Span 1 2 3 Truss L R Member TC BC MC Bay: 1

| Member Name: | Joint | Element | Joint | Remarks: |
|---|---|---|---|---|
| Condition Rating: | <u>5</u> | <u>5</u> | <u>5</u> | <i>- holes in lower portion of element</i> |

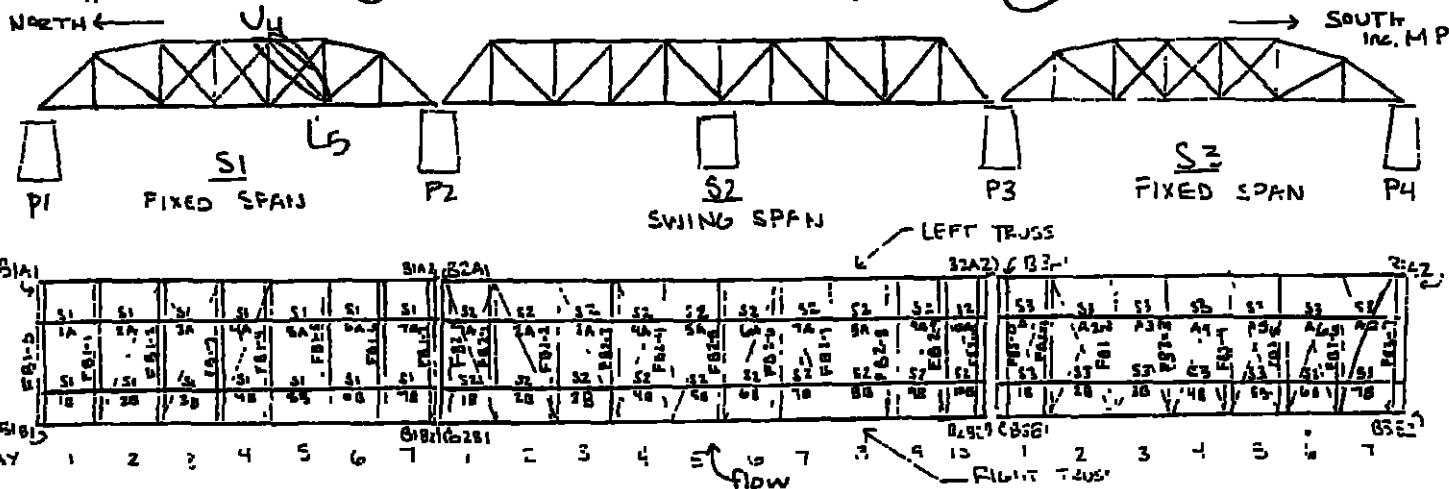
Member TC BC (MC)

| Member Name: | Joint | Element | Joint | Remarks: |
|---|---|---|---|---|
| Condition Rating: | 3 | 4 | 5 | |

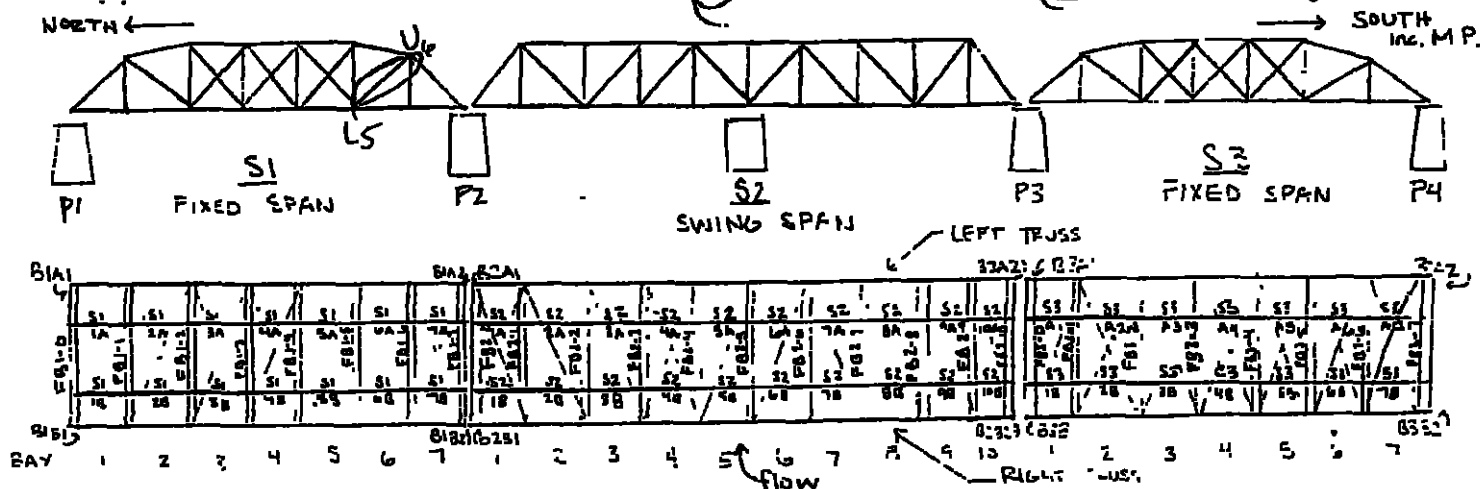
Location: Span (1) 2 3 Truss L (R) Member TC BC (MC) Bay: 6

| Member Name: | Joint | Element | Joint | Remarks: |
|---|---|---|---|---|
| Member Name: | L6 | 5 | U6 | moderate pack rust at L5 |
| Condition Rating: | 4 | 4 | 4 | |

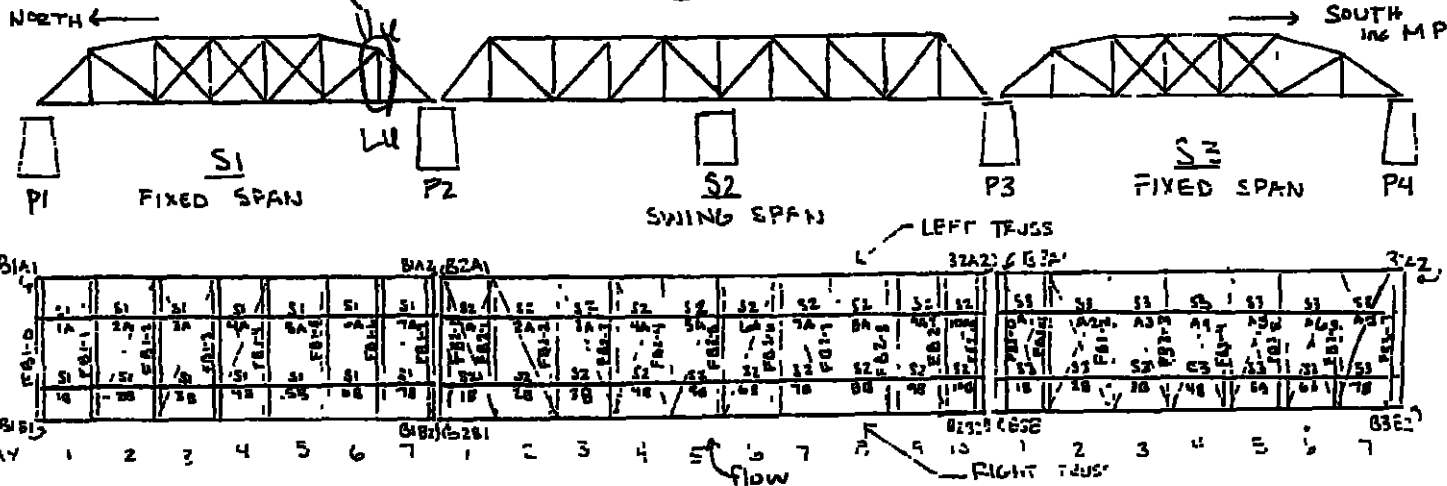
Span (1) 2 3Truss L (R)Member TC BC (MC)Bay:

| | Joint | Element | Joint | Remarks: |
|---|---|---|---|---|
| Member Name: | <u>U6</u> | <u>U6</u> | <u>U6</u> | <u>Laminar Rust</u> |
| Condition Rating: | <u>5</u> | <u>5</u> | <u>5</u> | |

NBI: 2 Condition: 5 Material Loss (%): 75  
Remarks: holes in elements

NBI: 3 Condition: 5 Material Loss (%): 25%  
Remarks:

NBI: 4 Condition: 5 Material Loss (%):         
Remarks:

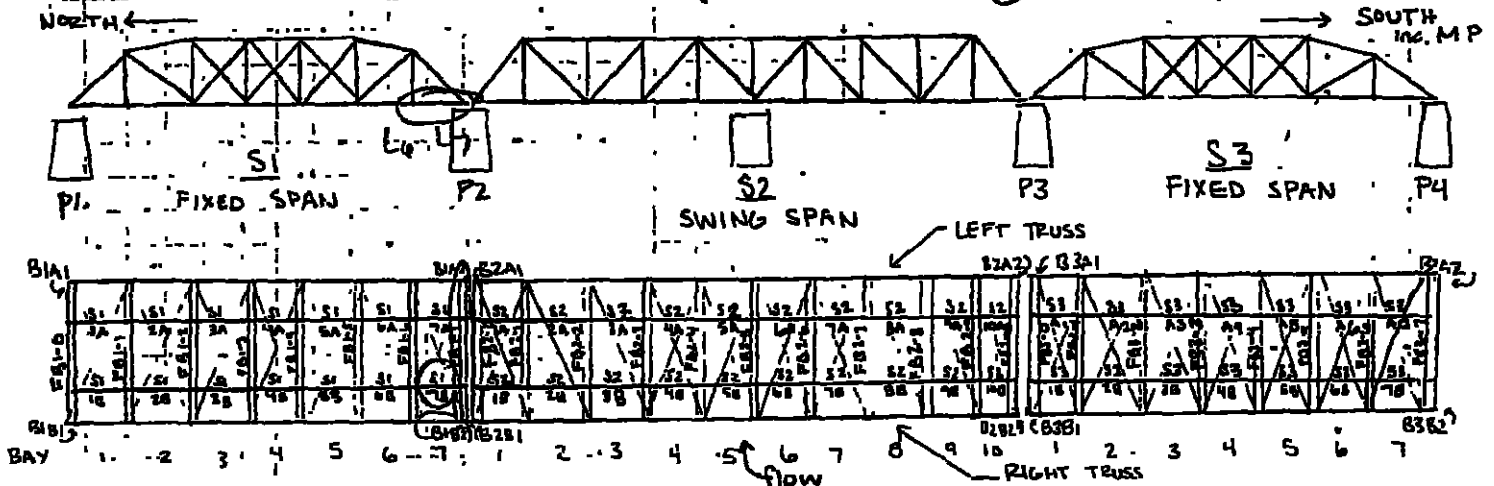
Member TC BC MC

| | Joint | Element | Joint | Remarks: |
|---|---|---|---|---|
| Condition Rating: | 5 | 5 | 5 | |

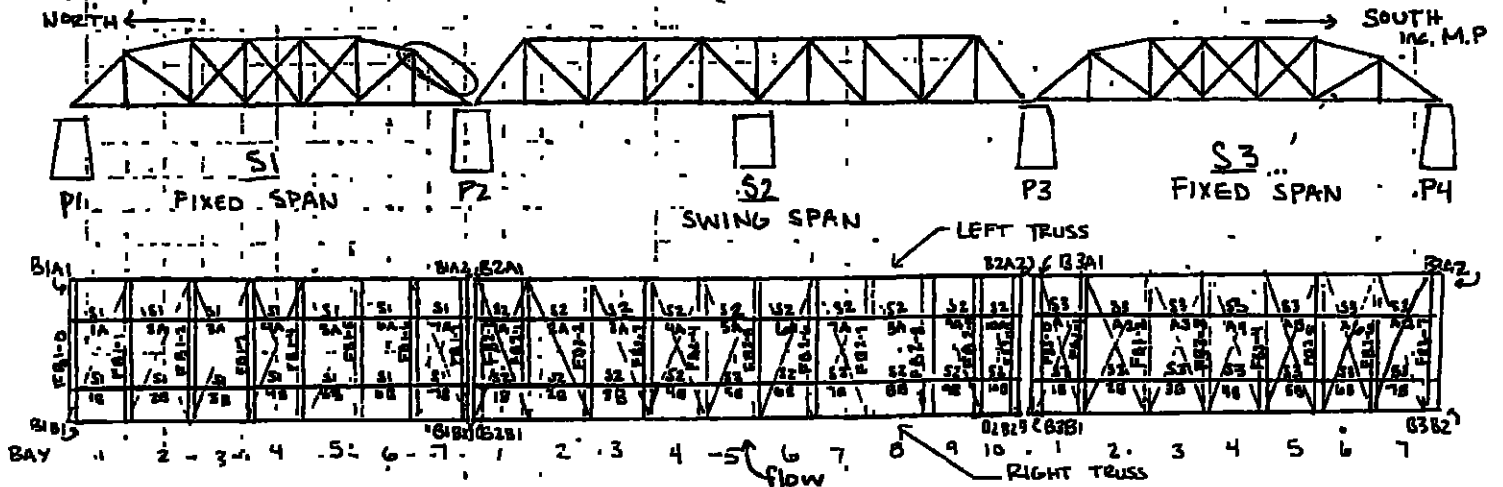
Location: Span (1) 2 3 Truss L (R) Member TC BC (MC) Bay: 7

| Member Name: | Joint | Element | Joint | Remarks: |
|---|---|---|---|---|
| BI Rating: | 4 | 4 | 4 | 10 of rivets are loose |
| Condition Rating: | 5 | 5 | 5 | LT pack nut |

Gross Brace:  
NBI: 2 Condition: 5 Material Loss (%): 75 \*  
Remarks: holes in plate

Floor Beam:  
NBI: 2 Condition: 5 Material Loss (%): 75 \*  
Remarks:

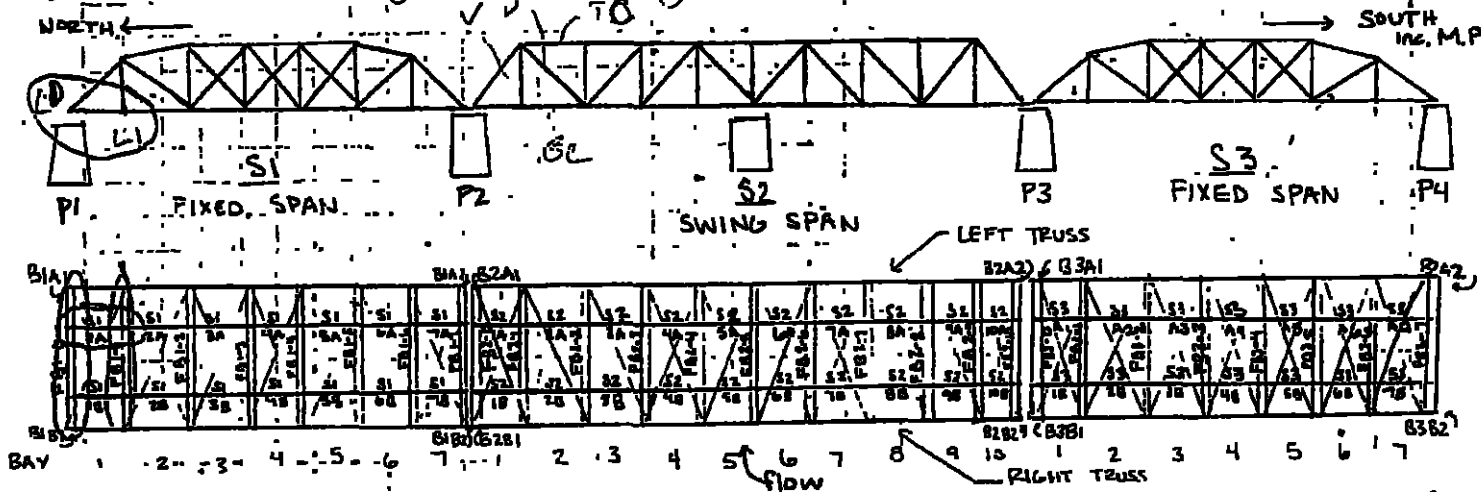
Location: Span 1/2 3 Truss (L) R Member TC/BG MC Bay: 1

| | Joint | Element | Joint | Remarks: |
|---|---|---|---|---|
| Condition Rating: | <u>5</u> | <u>5</u> | <u>5</u> | |

NBI: 6 Condition: 3 Material Loss (%): 0

NBI: 3 Condition: 5 Material Loss (%): 10

Remarks: TOP FL. 100% CORROSION, 20% SL 5% TO 60% LIFE, PAPER USE BRIDGE. DO NOT STAY TO FB.

NBI: 5 Condition: 4 Material Loss (%): 20

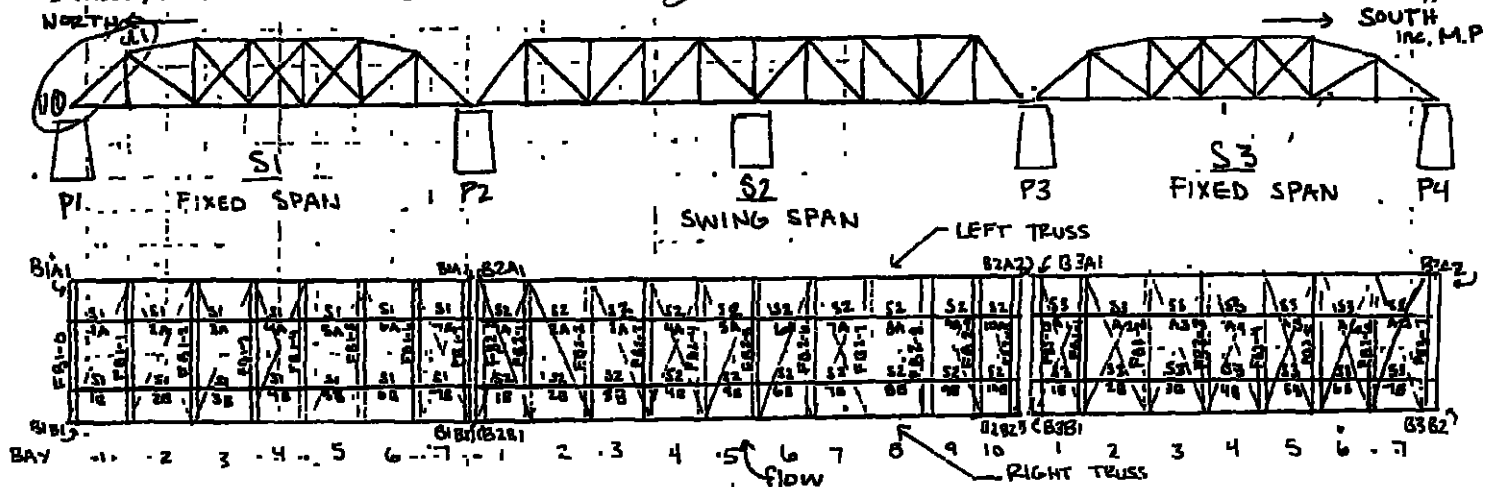
Location: Span 1 2 3 Truss TC R. Member TC BC MC Bay:

| | Joint | Element | Joint | Remarks: |
|---|---|---|---|---|
| Condition Rating: | <u>5</u> | <u>5</u> | <u>5</u> | |

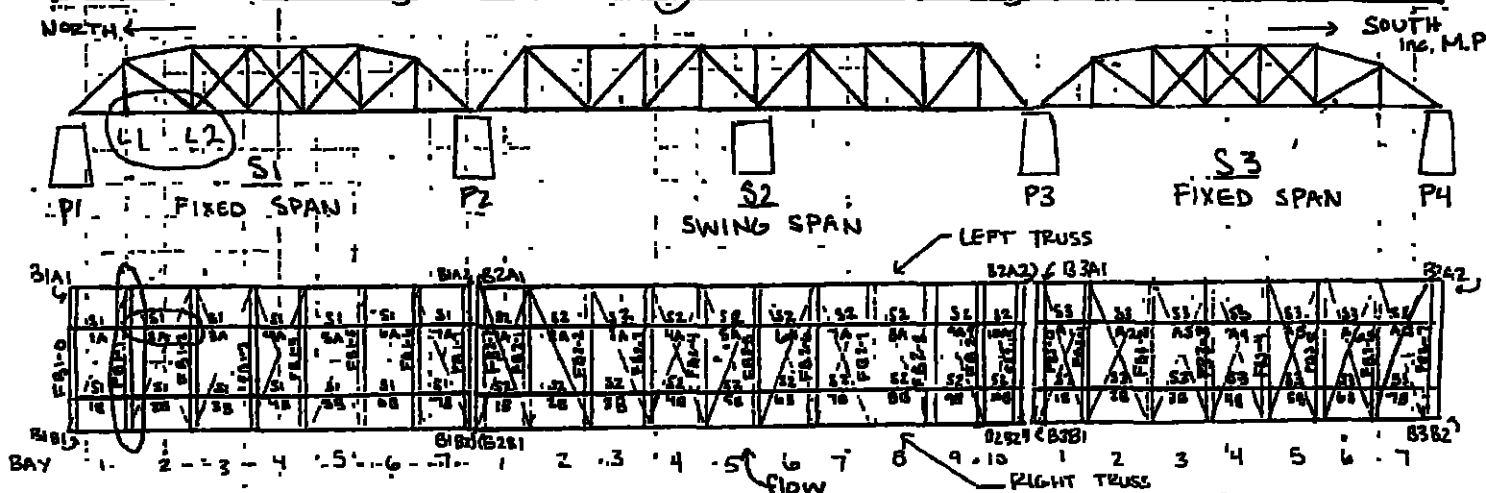
Location: Span/(1) 2 3 Truss (L) R Member TC /BC/ MC Bay: 2

| | Joint | Element | Joint | Remarks: |
|---|---|---|---|---|
| Condition Rating: | 5 | 5 | 5 | |

Cross Brace: \_\_\_\_\_  
NBI: 6 Condition: 3 (TYP.) Material Loss (%): \_\_\_\_\_  
Remarks: \_\_\_\_\_

Floor Beam: FBI-1  
NBI: 3 Condition: 5 Material Loss (%): \_\_\_\_\_  
Remarks: Heavy LAM RUST AT L1 CORN.

Stringer: S1-2A  
NBI: 4 Condition: 5 Material Loss (%): \_\_\_\_\_  
Remarks:

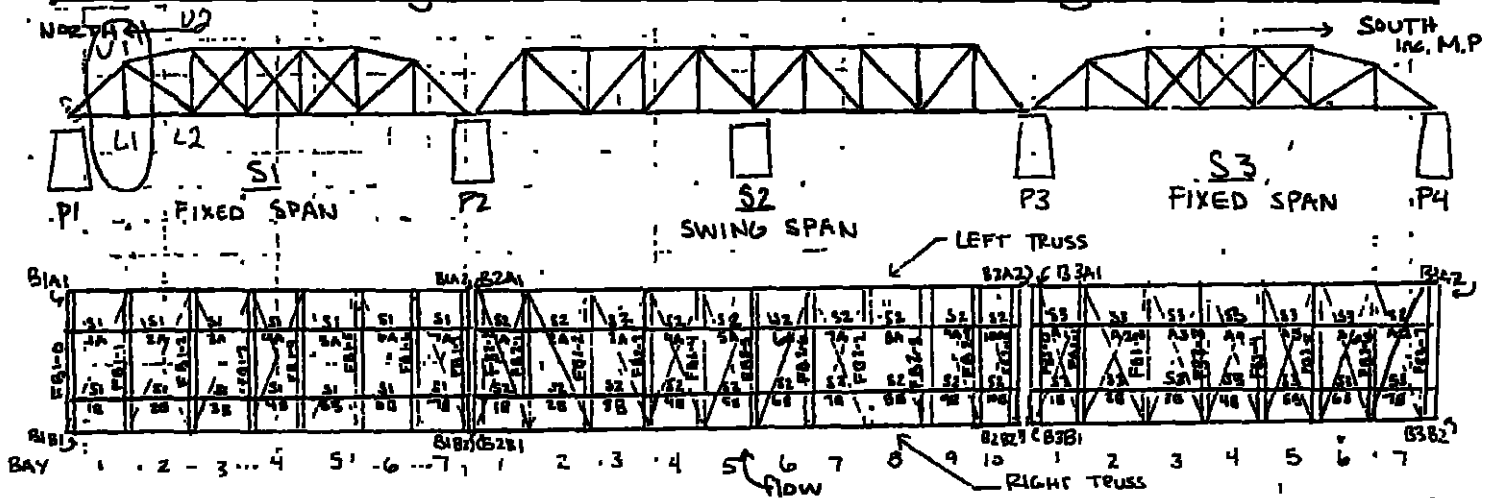
Location: Span (1) 2 3 Truss (L) R Member TC BC (MC) Bay: 1/2

| Member Name: | Joint | Element | Joint | Remarks: |
|---|---|---|---|---|
| Condition Rating: | 5 | 5 | 5 | |

Upper Pin: 121  
NBI: 4 Condition: 5 Material Loss (%):  
Remarks:

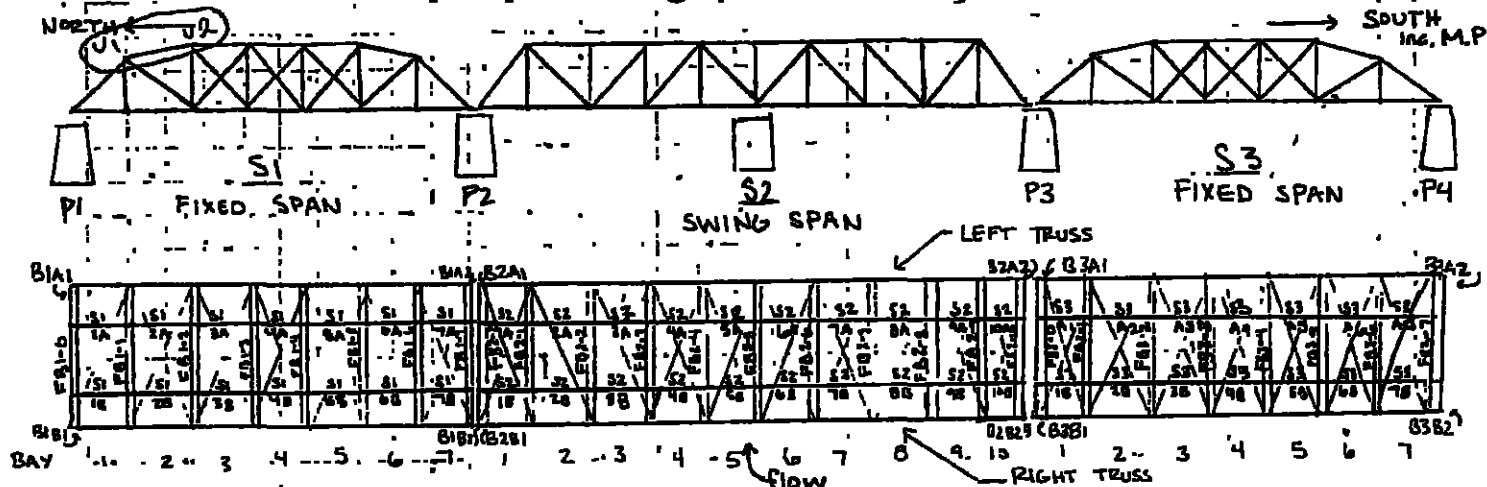
Location: Span (1) 2 3 Truss 4 R Member TC BC MC Bay: 2

| | Joint | Element | Joint | Remarks: |
|---|---|---|---|---|
| Condition Rating: | <u>5</u> | <u>5</u> | <u>5</u> | |

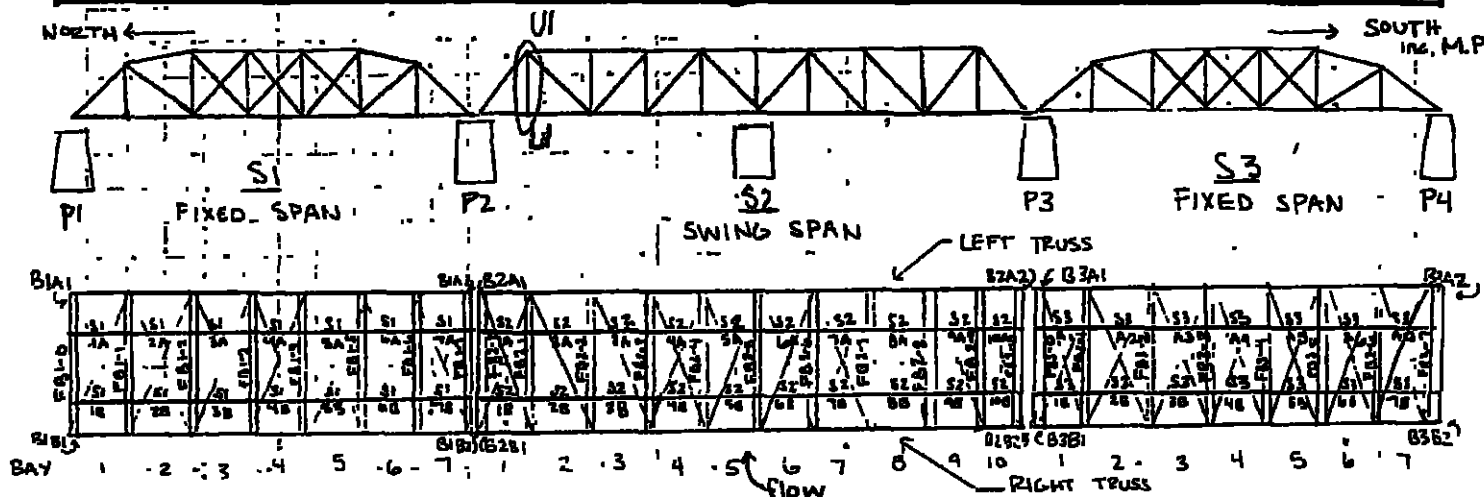
Location: Span 1 (2) 3 Truss L (R) Member TC BC (MC) Bay: 1/2

| | Joint | Element | Joint | Remarks: |
|---|---|---|---|---|
| Condition Rating: | 5 | 5 | 5 | |

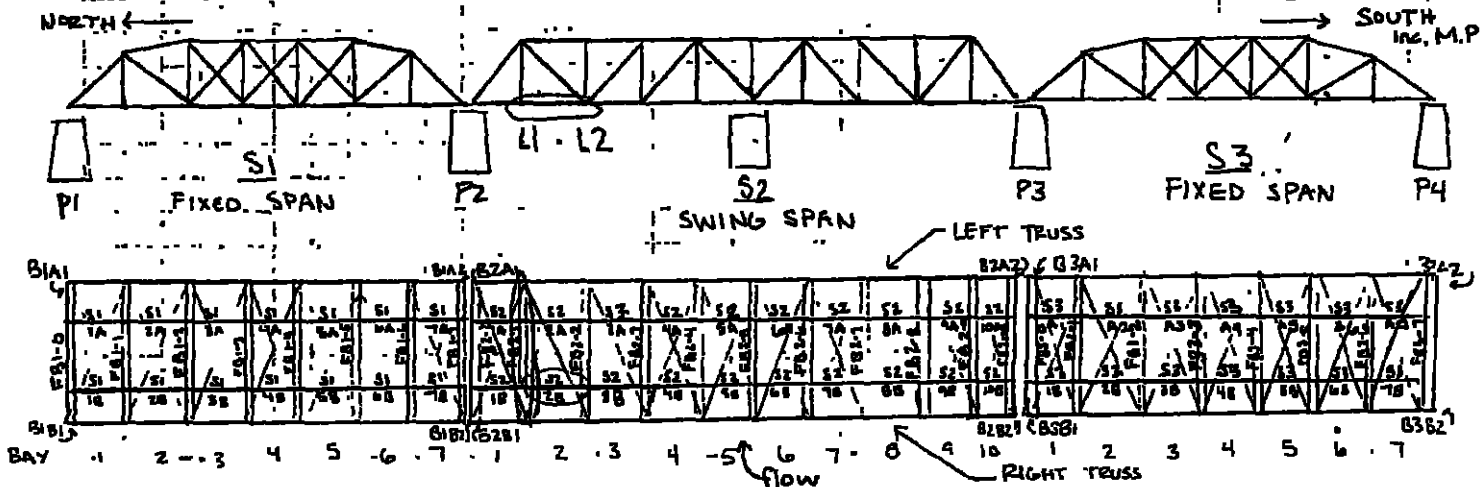
Location: Span 1 (2) 3 Truss L (R) Member TC (BC) MC Bay: 2

| Member Name: | Joint | Element | Joint | Remarks: |
|---|---|---|---|---|
| Condition Rating: | 5 | 5 | 5 | |

Cross Brace: 2 Condition: 5 Material Loss (%): 40  
Remarks: Ref. to LALL

Floor Beam: FB2  
NBI: 3 Condition: 5 Material Loss (%): 15  
Remarks: rated on LALL sheet

Stringer: 21B  
NBI: 3 Condition: 5 Material Loss (%): 15  
Remarks: 75% 15%

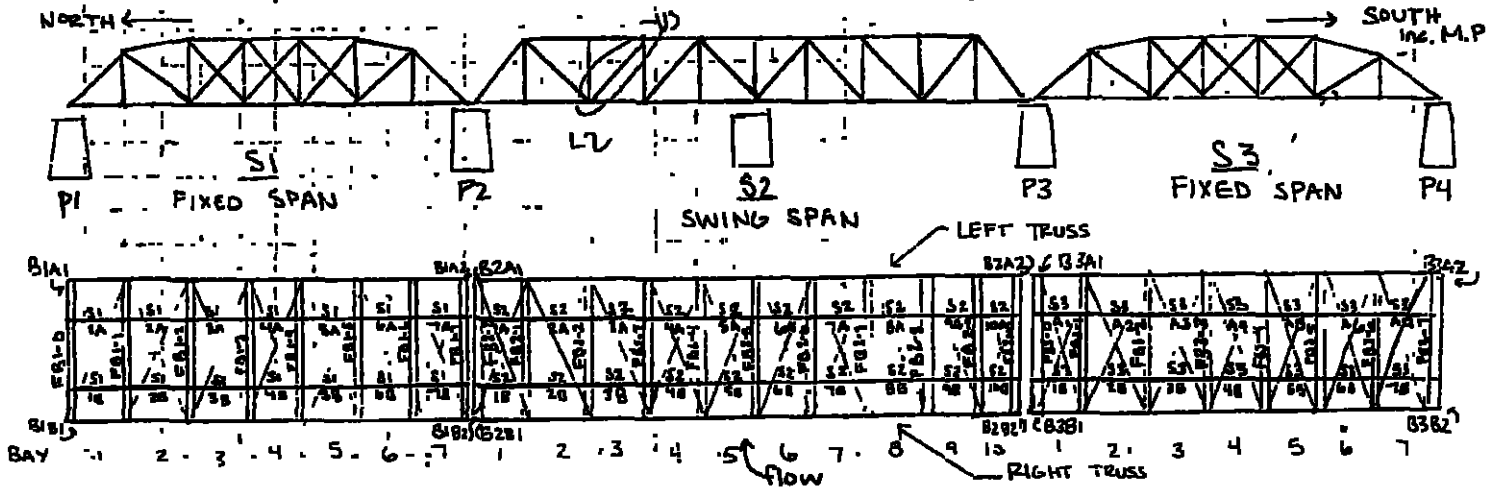
Location: Span 1 (2) 3 Truss L (R) Member TC BC MC Bay: 3

| Member Name: | Joint | Element | Joint | Remarks: |
|---|---|---|---|---|
| Member Name: | L2 | | U3 | heavy rusty inflection |
| Condition Rating: | 5 | 5 | 5 | severe corrosion and pitting, fast rivets and connections |

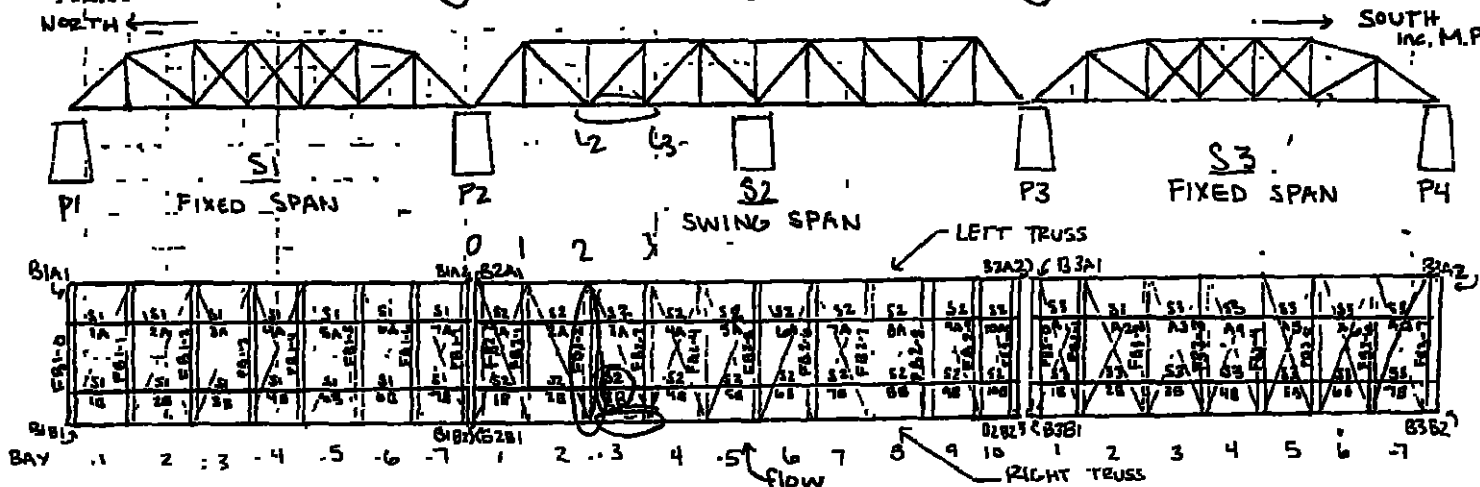
Bay: 3

L2 - note 50% severe pitting and fresh rust

NBI: 5 Condition: 3 Material Loss (%): 5

NBI: 3 Condition: 5 Material Loss (%): 25

Remarks: fresh rust along connection, limited rust

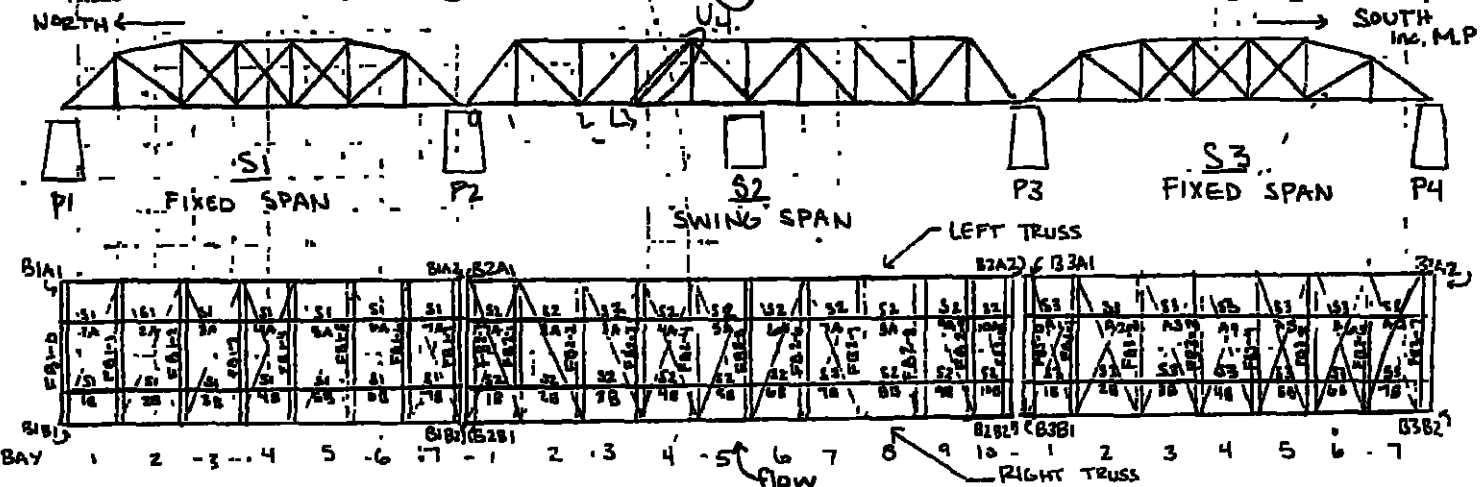
Location: Span 1 (2) 3 Truss L R Member TC BC MC Bay: 4

| Member Name: | Joint | Element | Joint | Remarks: |
|---|---|---|---|---|
| Condition Rating: | 3 | 3 | 3 | |

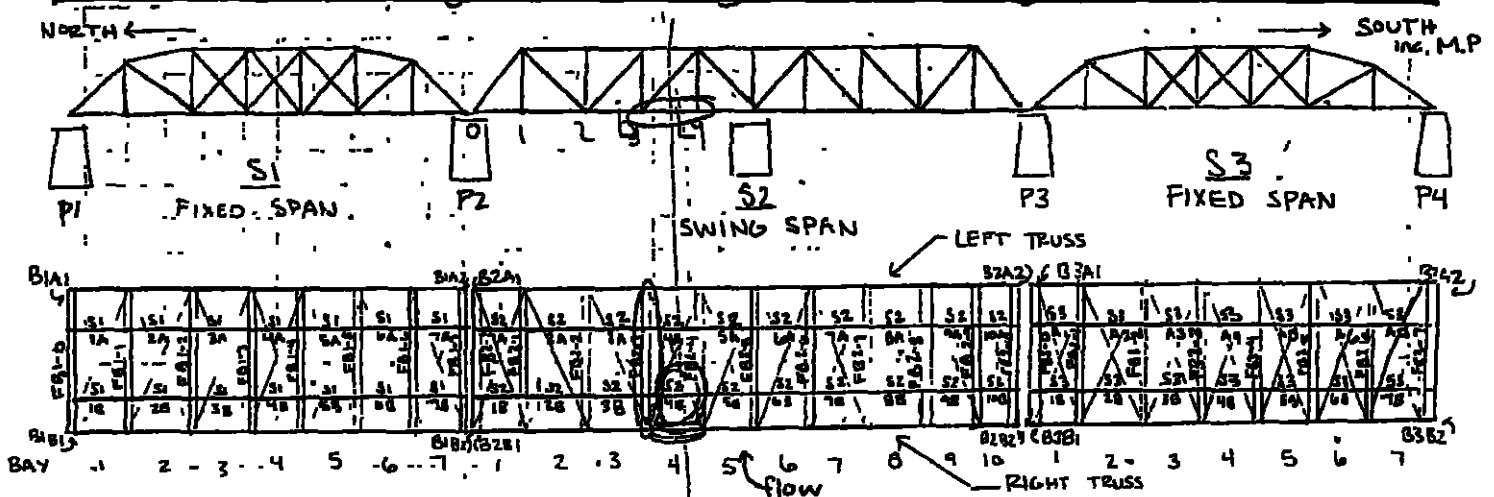
Location: Span 1 (2) 3 Truss L (R) Member TC (BC) MC Bay: 4

| Member Name: | Joint | Element | Joint | Remarks: |
|---|---|---|---|---|
| Condition Rating: | 5 | 5 | 5 | |

Floor Beam: F82-3  
NBI: 3 Condition: 5 Material Loss (%): →  
Remarks: \_\_\_\_\_

Stringer: S24B  
NBI: 3 Condition: 5 Material Loss (%): ~  
Remarks: \_\_\_\_\_

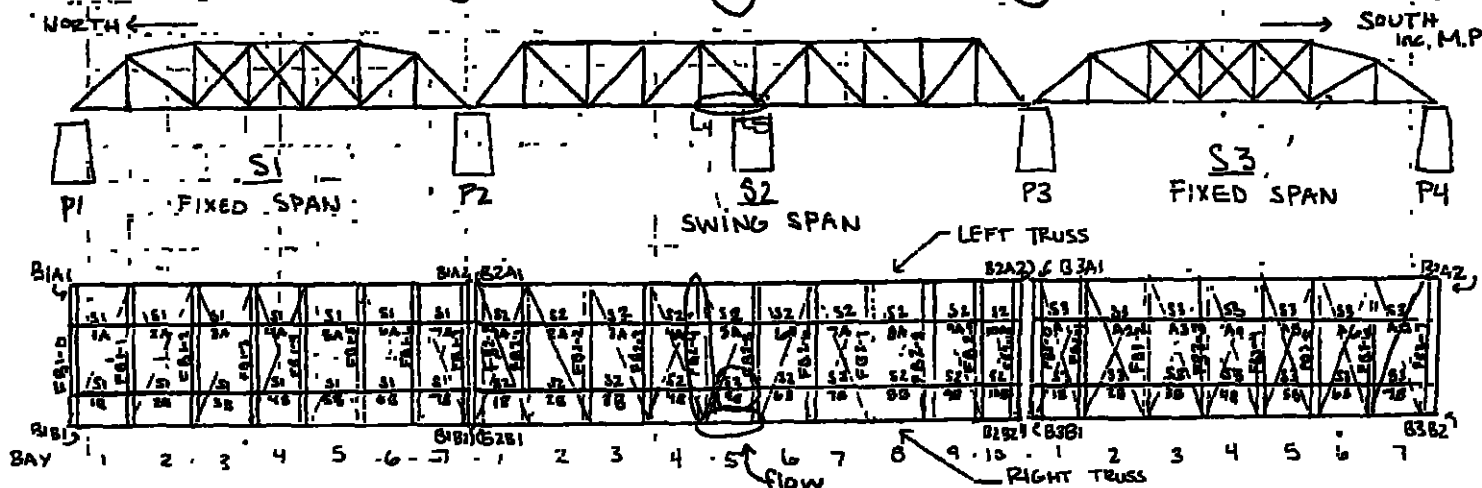
Location: Span 1 (2) 3 Truss L (R) Member TC (BC) MC Bay: 5

| Member Name: | Joint | Element | Joint | Remarks: | % Gusset Plate |
|---|---|---|---|---|---|
| Condition Rating: | 5 | 5 | 5 | | |

NBI: Condition: Material Loss (%): 15

NBI: 4 Condition: 5 Material Loss (%): 25

NBI: 3 Condition: 5 Material Loss (%):

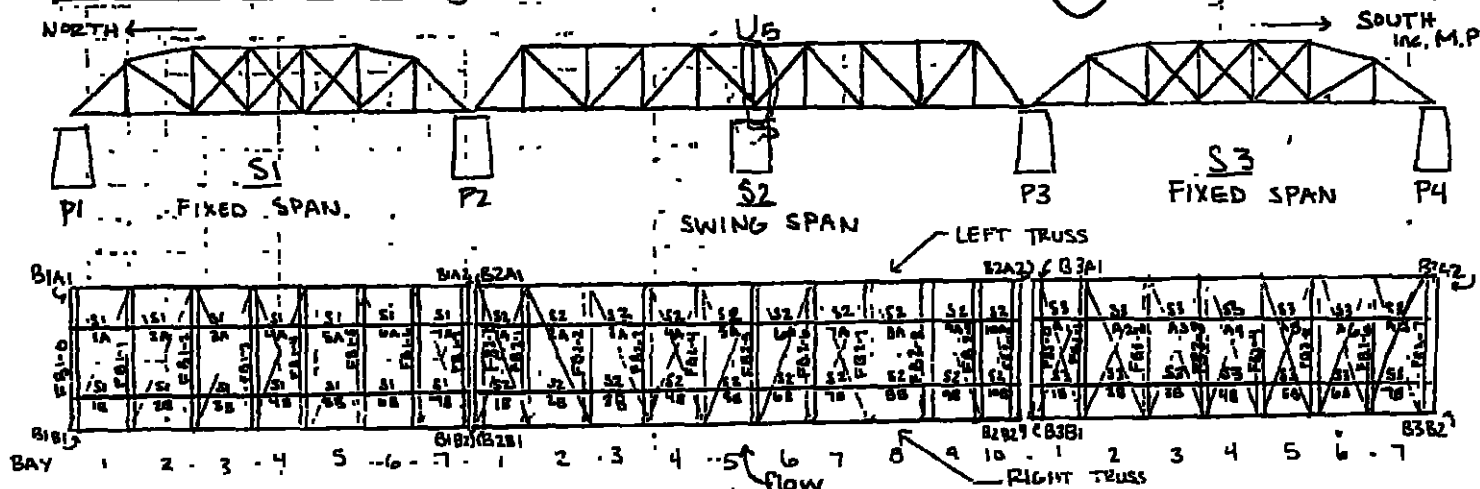
Location: Span 1 (2) 3 Truss L (R) Member TC BC (MC) Bay: S/6

| | Joint | Element | Joint | Remarks: |
|---|---|---|---|---|
| Member Name: | L5 | | U5 | <i>loose ineffective</i> |
| Condition Rating: | 5 | 5 | 5 | |
| Material Loss (%): | 10 | 20 | 25 | <i>rust and pitting</i> |

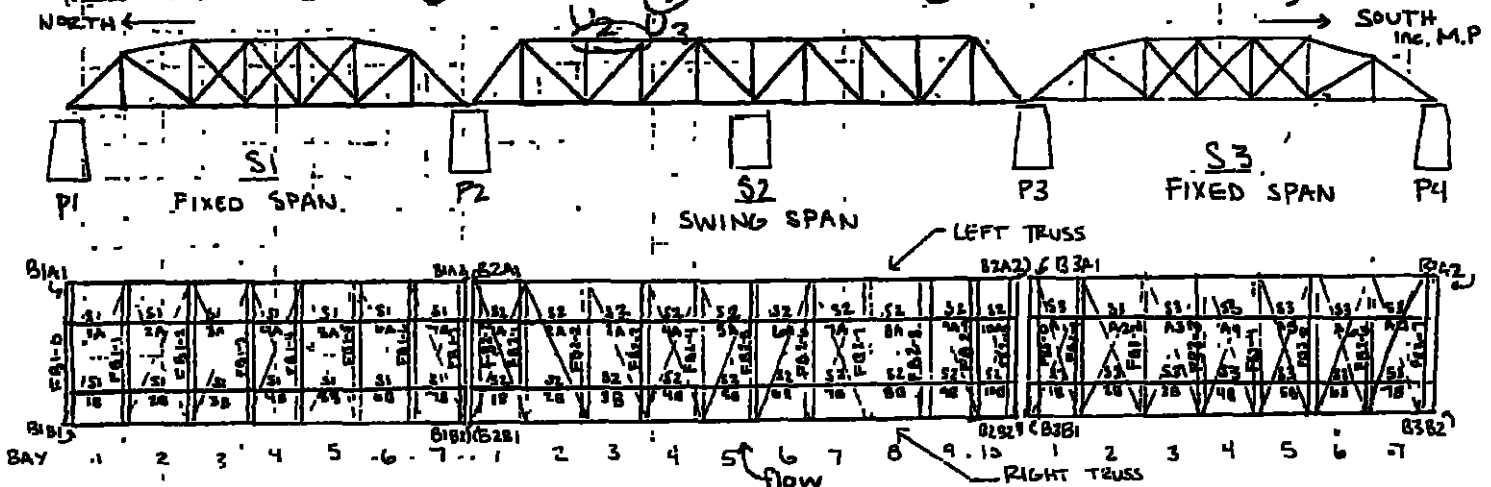
Typical  
all top cords

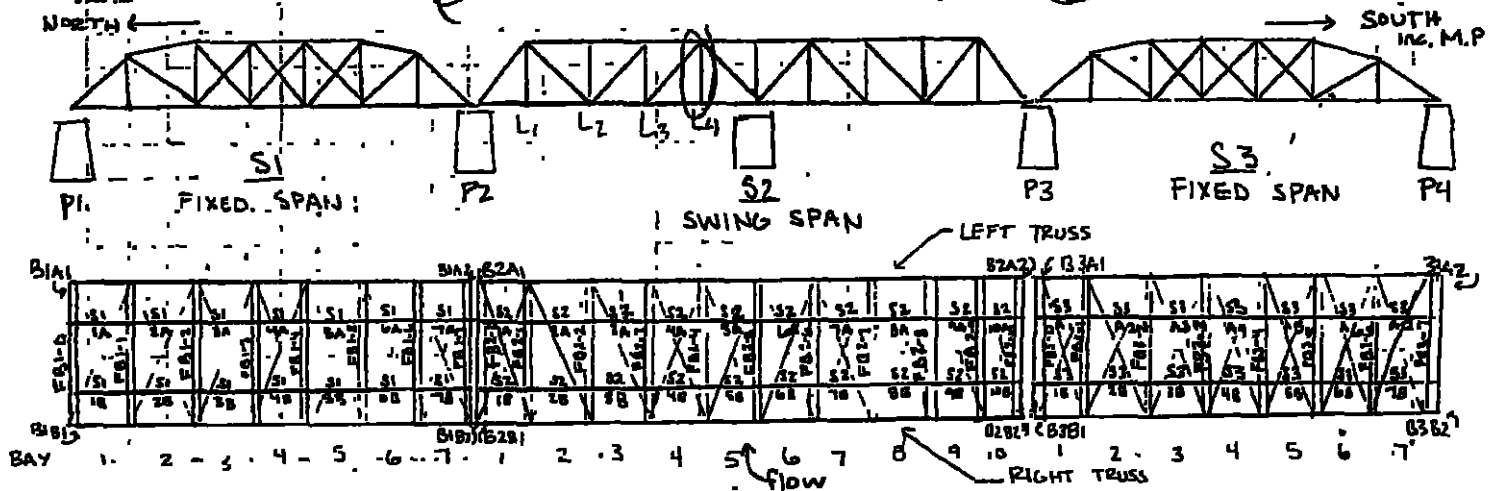
Location: Span 1 (2) 3 Truss (L) R Member TC BC (MC) Bay: -

| Member Name: | Joint | Element | Joint | Remarks: |
|---|---|---|---|---|
| NBI Rating: | 3 | 3 | 3 | web corrosion about 25% |

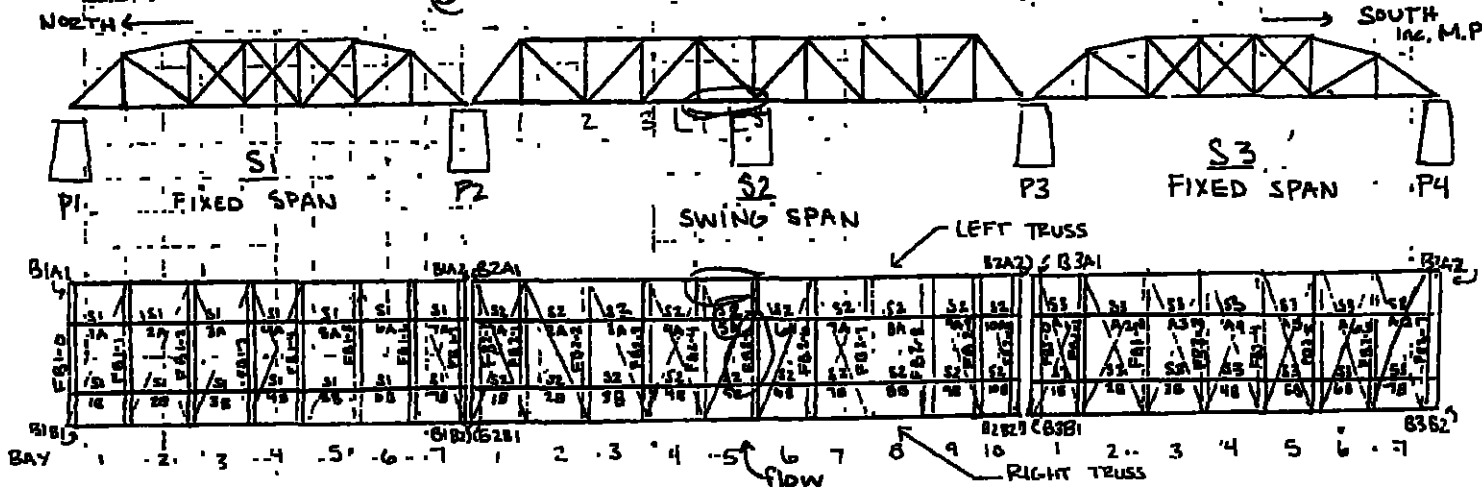
Location: Span 1 2 3 Truss (L) R Member TC (BC) MC Bay: 5

| Member Name: | Joint | Element | Joint | Remarks: |
|---|---|---|---|---|
| Member Name: | L4 | | L5 | Corrosion |
| Condition Rating: | 5 | 5 | 5 | holes in gusset plate |

Floor Beam: FB2-5  
NBI: 3 Condition: 6 Material Loss (%): 35%  
Remarks:

Stringer: S2-5A  
NBI: 3 Condition: 5 Material Loss (%): ALL → 75  
Remarks: 10% mat loss  
-25

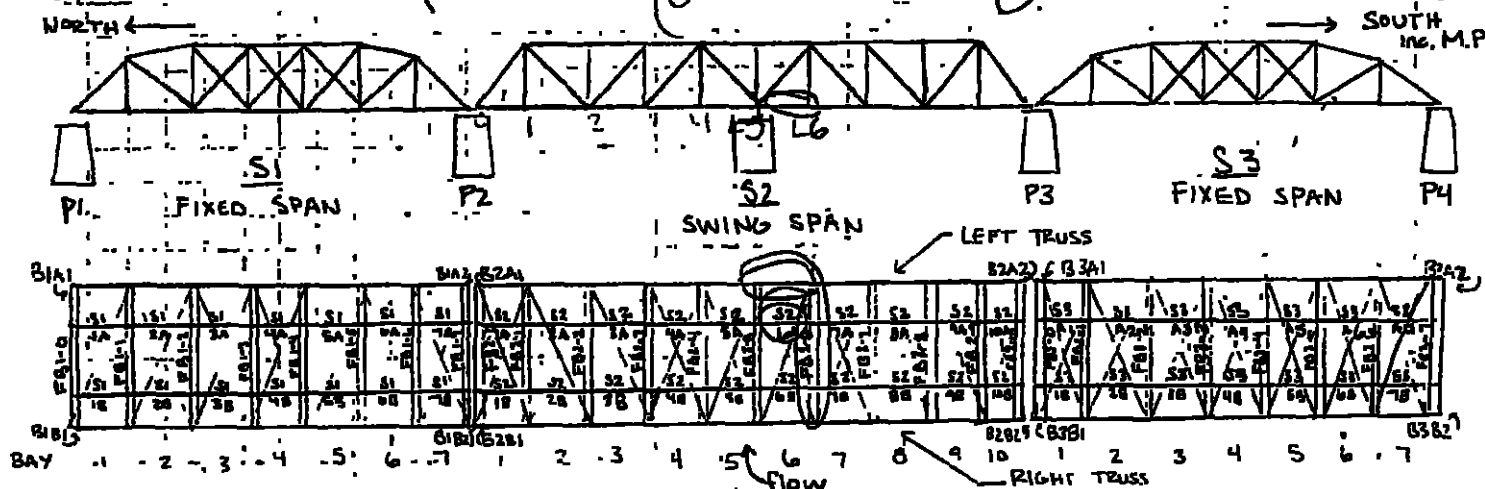
Location: Span 1 (2) 3 Truss (L) R Member TC (BC) MC Bay: 6

NBI: 3 Condition: 5 Material Loss (%): 10%

Remarks: minor partition rust
