# Coos Bay Rail Link Bridge Condition Assessment

## Draft Report – Volume 3 of 3

**OREGON DEPARTMENT OF TRANSPORTATION  
RAIL DIVISION  
CORP BRIDGE 716.4**

**INSPECTION REPORT**

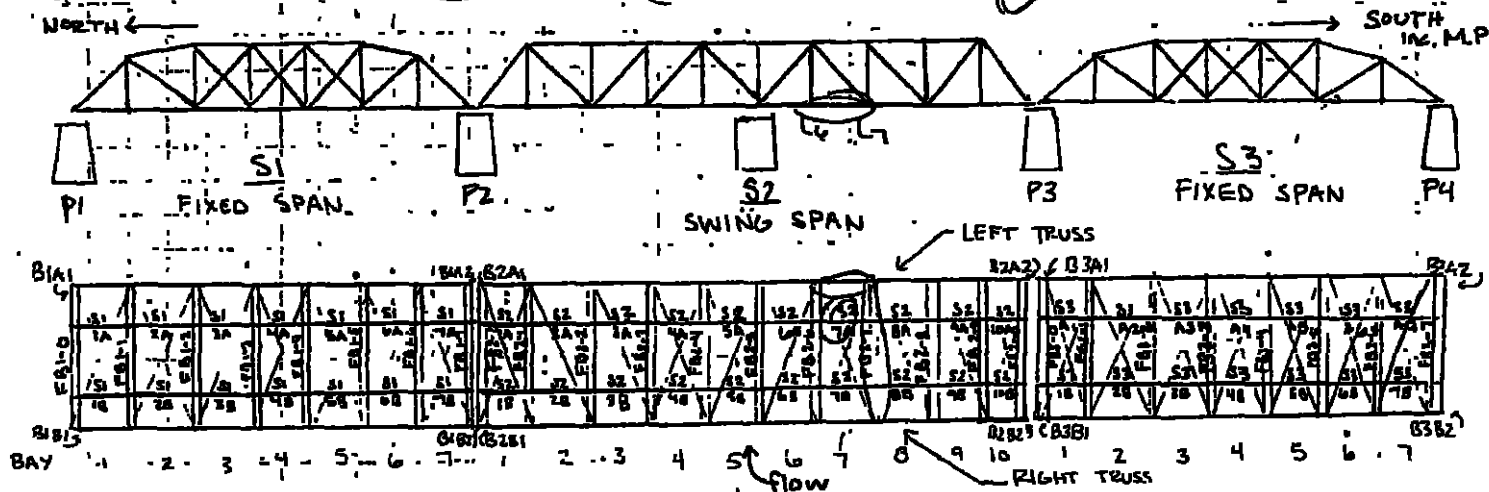
Bay: 7

Cross Brace: 7 - 2  
 NBI: 5 Condition: 4 Material Loss (%): 5%  
 Remarks:

Floor Beam: 7 - 2  
 NBI: 3 Condition: 5 Material Loss (%): 5%  
 Remarks:

Stringer: S2 - 7A  
 NBI: 3 Condition: 5 Material Loss (%): 1  
 Remarks:

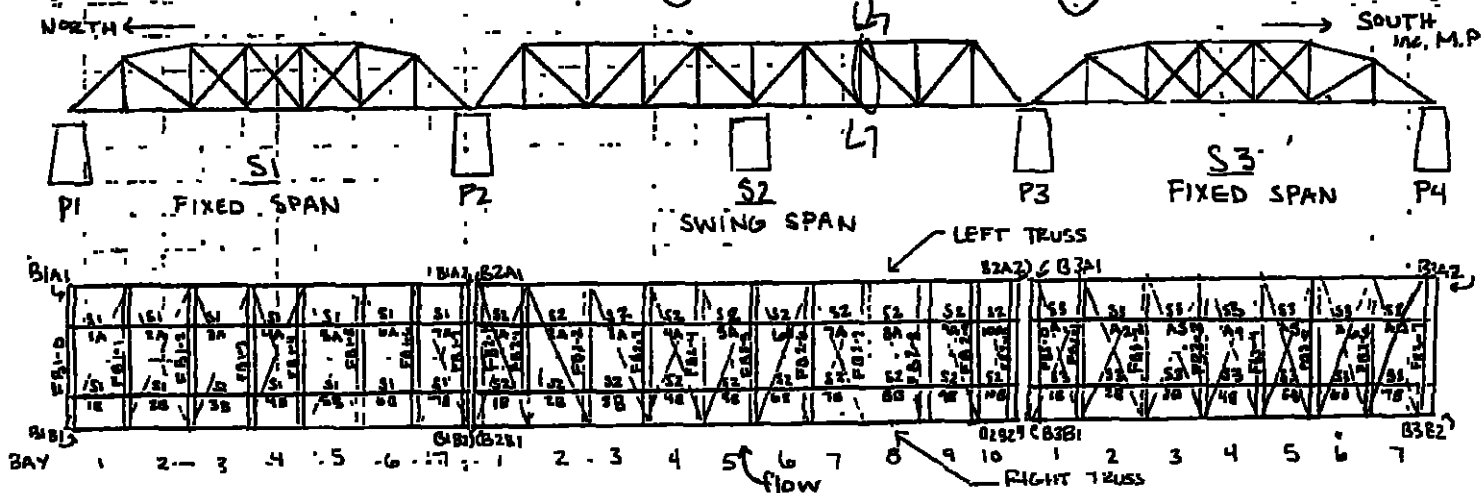
Location: Span 1 (2) 3 Truss (L) R Member TC BC (MC) Bay:

| Member Name: | Joint | Element | Joint | Remarks: |
|---|---|---|---|---|
| Condition Rating: | 5 | 5 | 5 | heavy pitting |

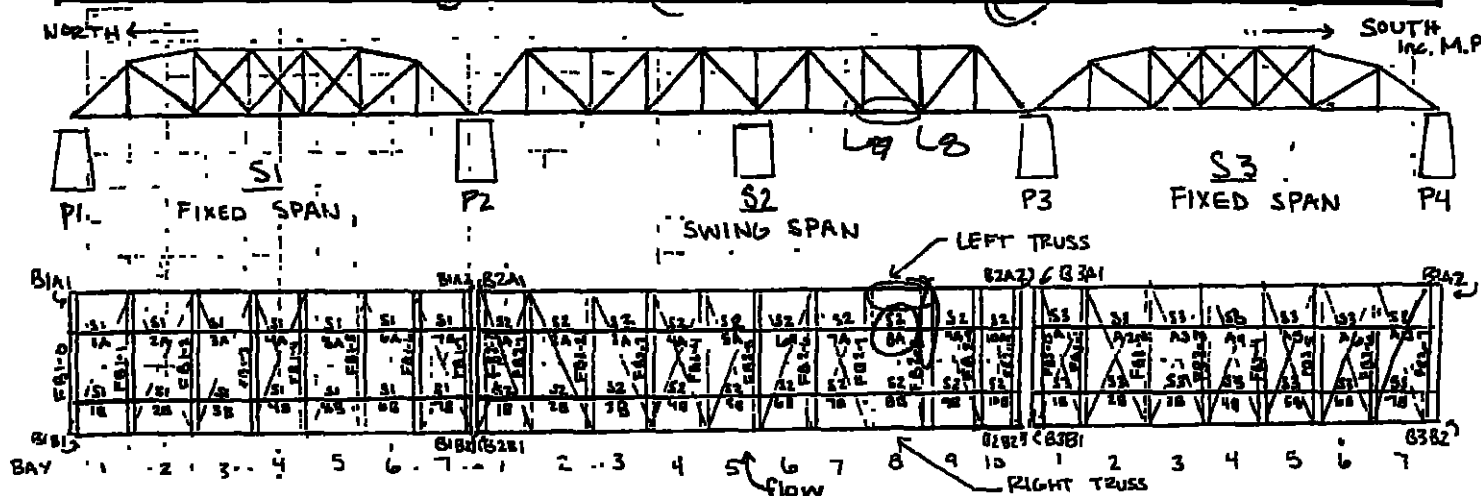
Location: Span 1 (2) 3 Truss (1) R Member TC (BC) MC Bay: 3

| Member Name: | Joint | Element | Joint | Remarks: |
|---|---|---|---|---|
| Condition Rating: | <u>5</u> | <u>5</u> | <u>5</u> | <u>Notes on Flaring</u> |

Cross Brace: B-2 Span  
NBI: 4 Condition: 5 Material Loss (%): 5%  
Remarks:

Floor Beam: FB 2-3  
NBI: 3 Condition: 5 Material Loss (%): 25%  
Remarks: heaving driveway not at bot. Flange corr.

Stringer: S2-BA  
NBI: 2 Condition: 5 Material Loss (%): 25%  
Remarks:

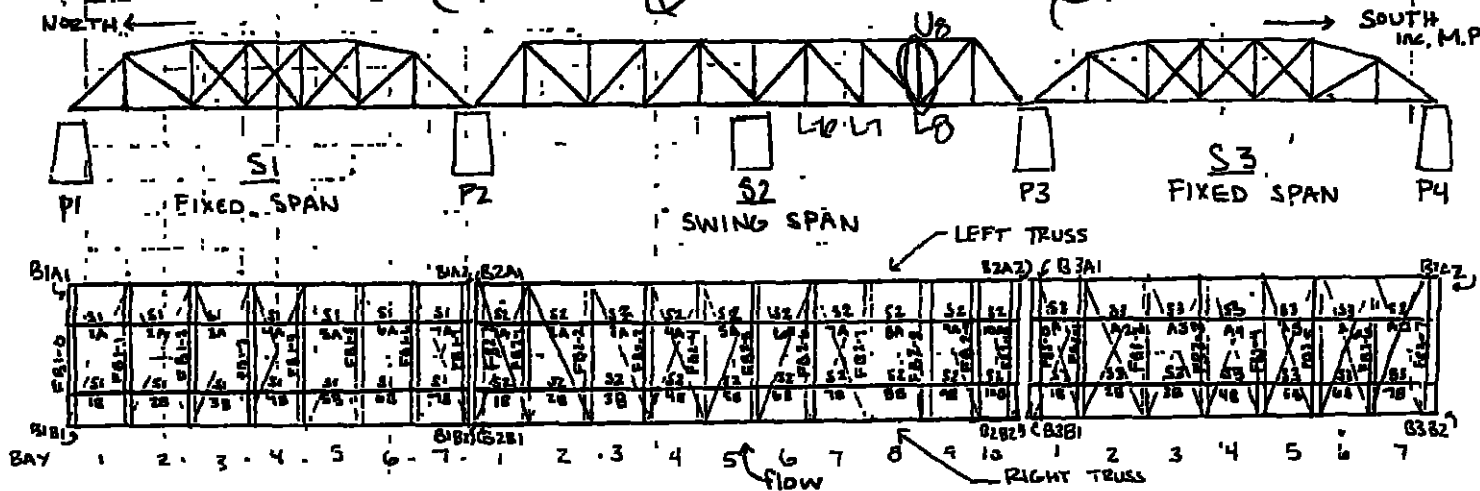
Location: Span 1 (2) 3 Truss (L) R Member TC BC (MC) Bay: \_\_\_\_\_

| Member Name: | Joint | Element | Joint | Remarks: |
|---|---|---|---|---|
| Condition Rating: | <u>5</u> | <u>5</u> | <u>5</u> | <u>heavy laminar rust at gusset</u> |

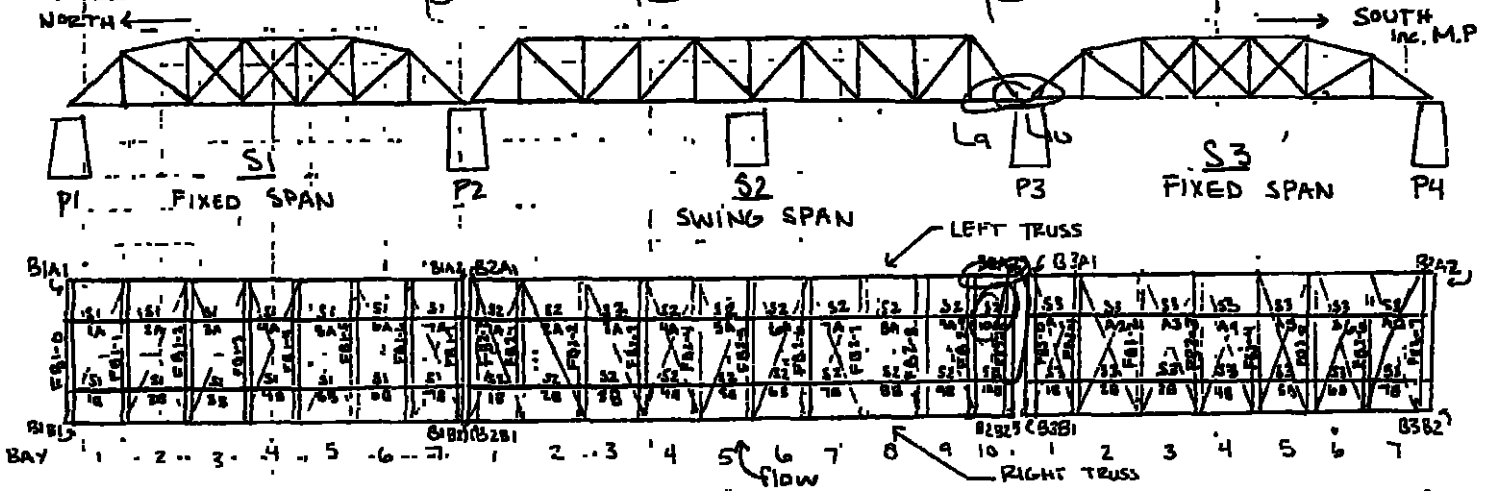
Bay: 10

| Member Name: | Joint | Element | Joint | Remarks: |
|---|---|---|---|---|
| Condition Rating: | 5 | 5 | 5 | top left " 25% |

Cross Brace: 10 - 2 span  
NBI: 4 Condition: 5 Material Loss (%): 5  
Remarks:

Floor Beam: F2-10  
NBI: 4 Condition: 5 Material Loss (%): 5  
Remarks:

Stringer: S2 10A  
NBI: 3 Condition: 5 Material Loss (%): 5  
Remarks:

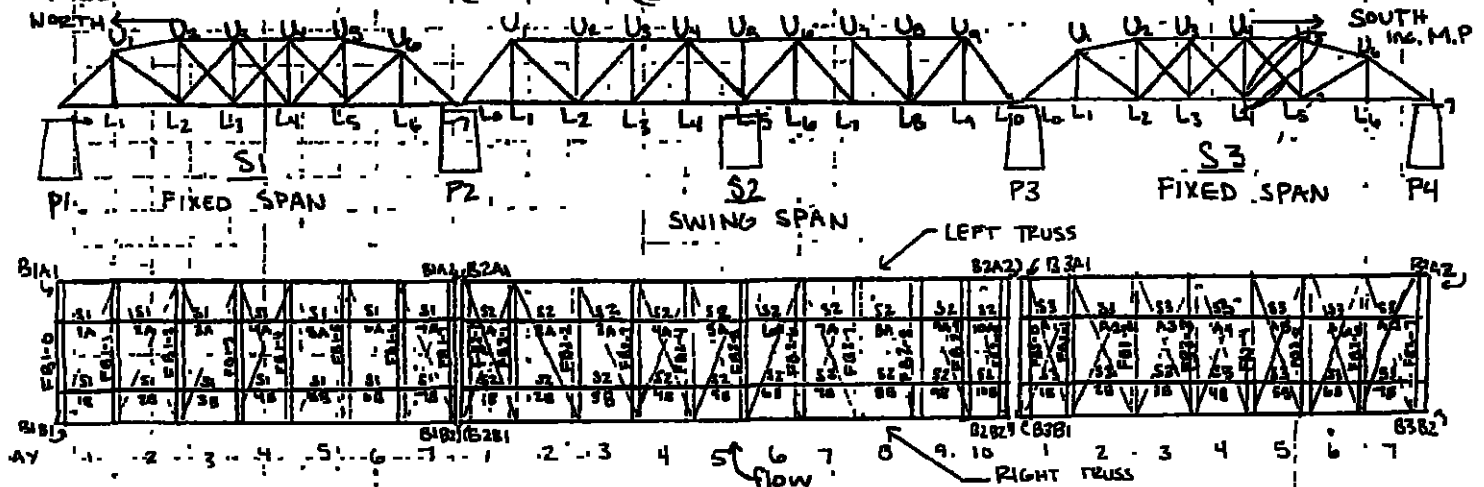
Location: Span 1 2 (3) Truss (L) R Member TC BC (MC) Bay: 5

| | Joint | Element | Joint | Remarks: |
|---|---|---|---|---|
| Rating: | 4 | 4 | 4 | moderate turn rust |
| Condition Rating: | 4 | 4 | 4 | |

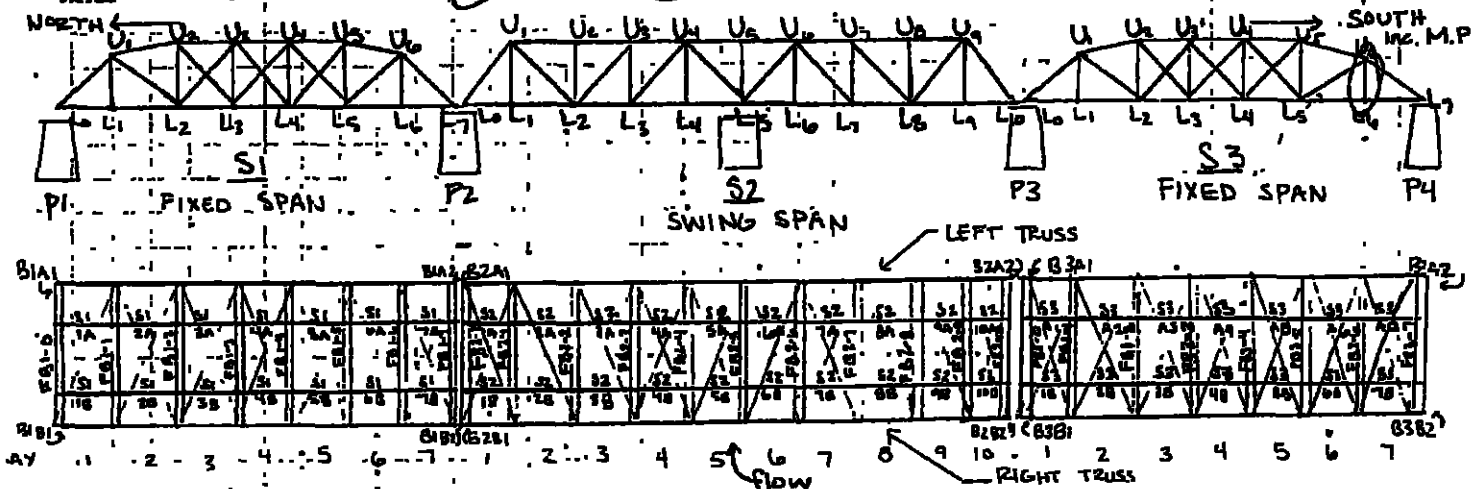
Bay: 6

| | Joint | Element | Joint | Remarks: |
|---|---|---|---|---|
| Rating: | 3 | 4 | 4 | spalling / pitting |
| Condition Rating: | 5 | 4 | 4 | |

Upper Pin: \_\_\_\_\_  
 NBI: \_\_\_\_\_ Condition: \_\_\_\_\_ Material Loss (%): \_\_\_\_\_  
 Remarks: NO BLOCKS see S1 U6L6

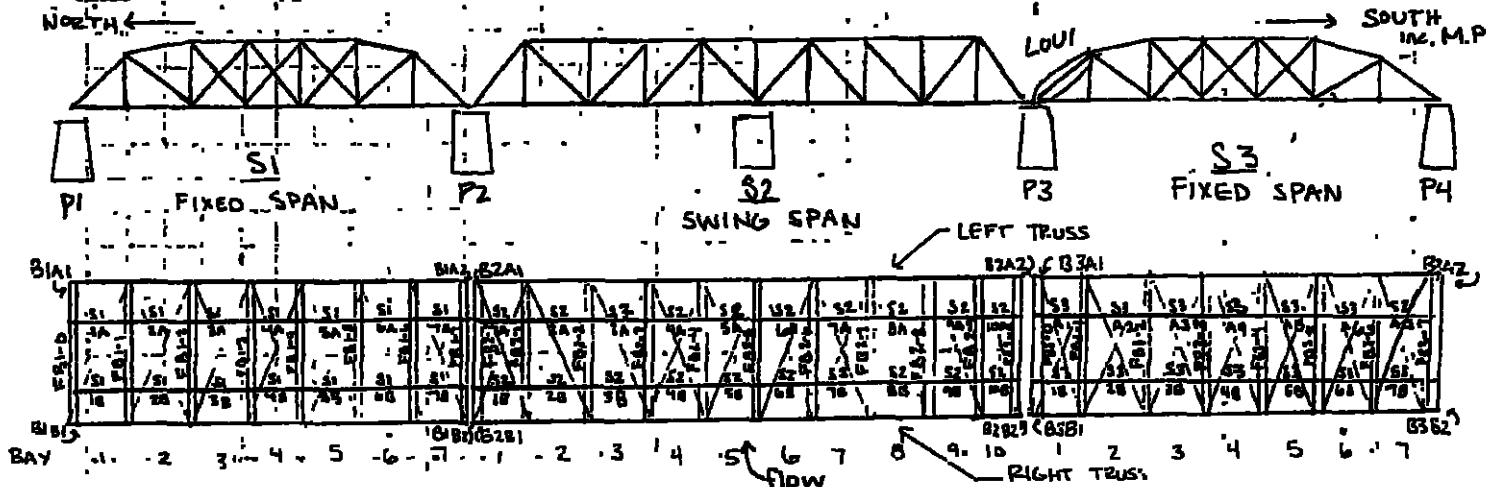
Bay: 1

| | Joint | Element | Joint | Remarks: |
|---|---|---|---|---|
| Condition Rating: | 5 | 5 | 5 | |

NBI: 6 Condition: 3 Material Loss (%): <1%

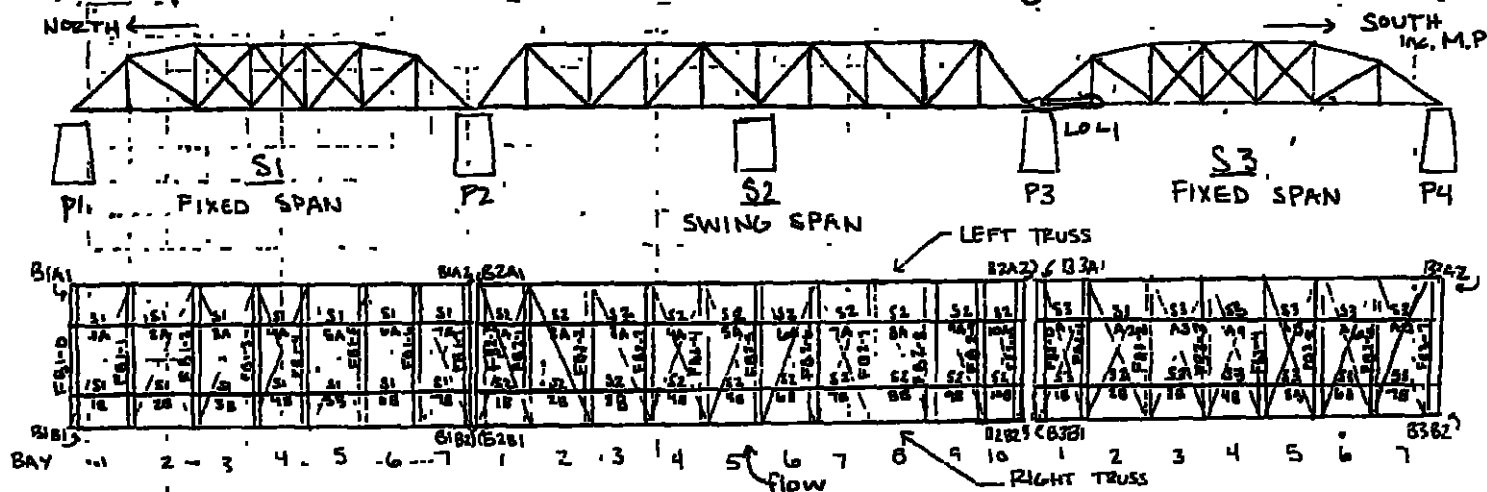
Location: Span 1 2 (3) Truss L R Member TC BC MC Bay: 1

| Member Name: | Joint | Element | Joint | Remarks: |
|---|---|---|---|---|
| Condition Rating: | 5 | 3 | 5 | |
| Material Loss (%): | 25 | → | 20 | some pulling & lacing, corroded flanges |

| NBI: 3 | Condition: 5 | Material Loss (%): → | 75' 25<br>50<br>25 |

| NBI: 3 | Condition: 5 | Material Loss (%): → | 75' 25<br>50 |

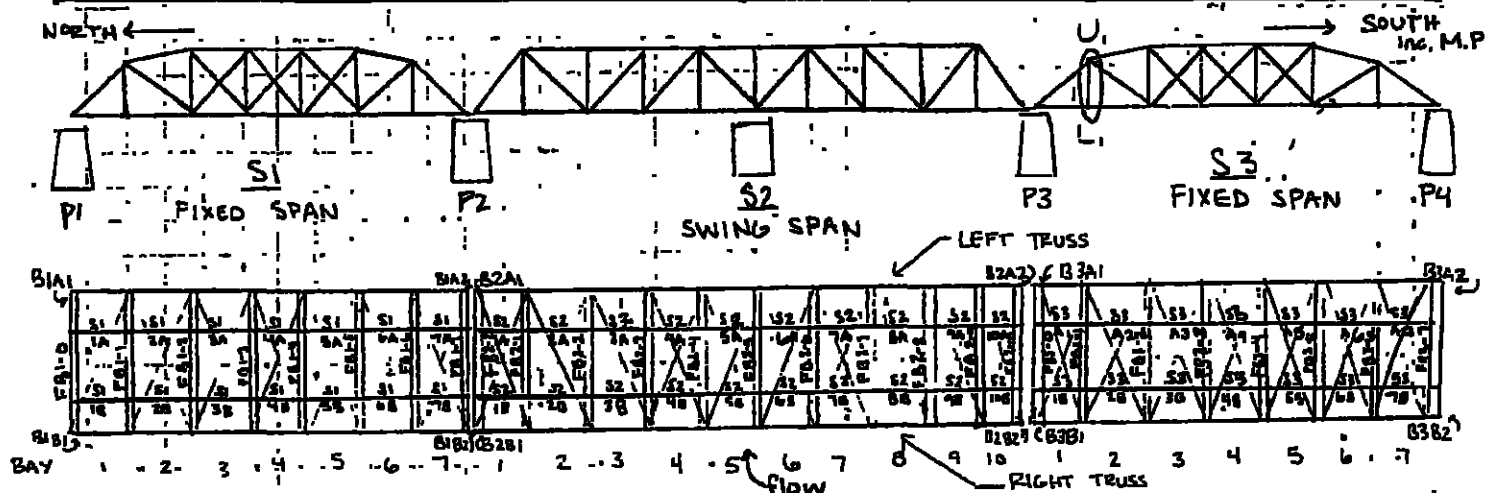
Location: Span 1 2 3 Truss L R Member TC BC MC Bay: 1/2

| Member Name: | Joint | Element | Joint | Remarks: |
|---|---|---|---|---|
| Condition Rating: | 3 | 4 | 5 | common di main element |

NBI: 6 Condition: 3 Material Loss (%): < 2%

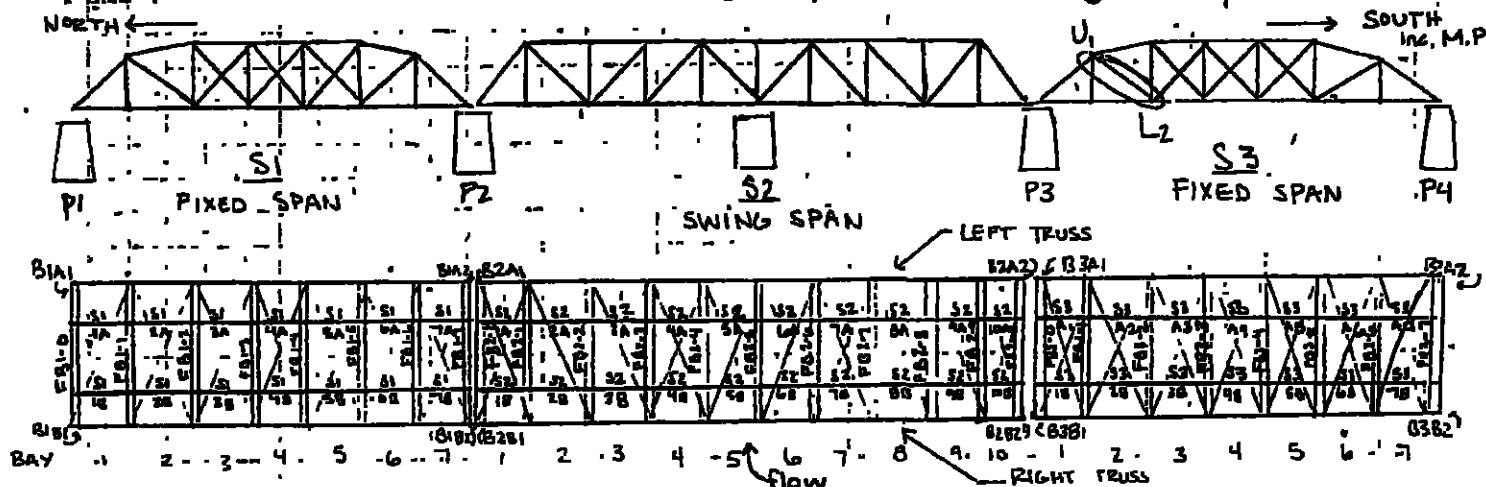
Location: Span 1 2 (3) Truss L (R) Member TC BC MG Bay: 2

| Member Name: | Joint | Element | Joint | Remarks: |
|---|---|---|---|---|
| Condition Rating: | 5 | 3 | 3 | |
| Material Loss (%): | ~2 | 10 | 20 | pail rust @ L2 joint |

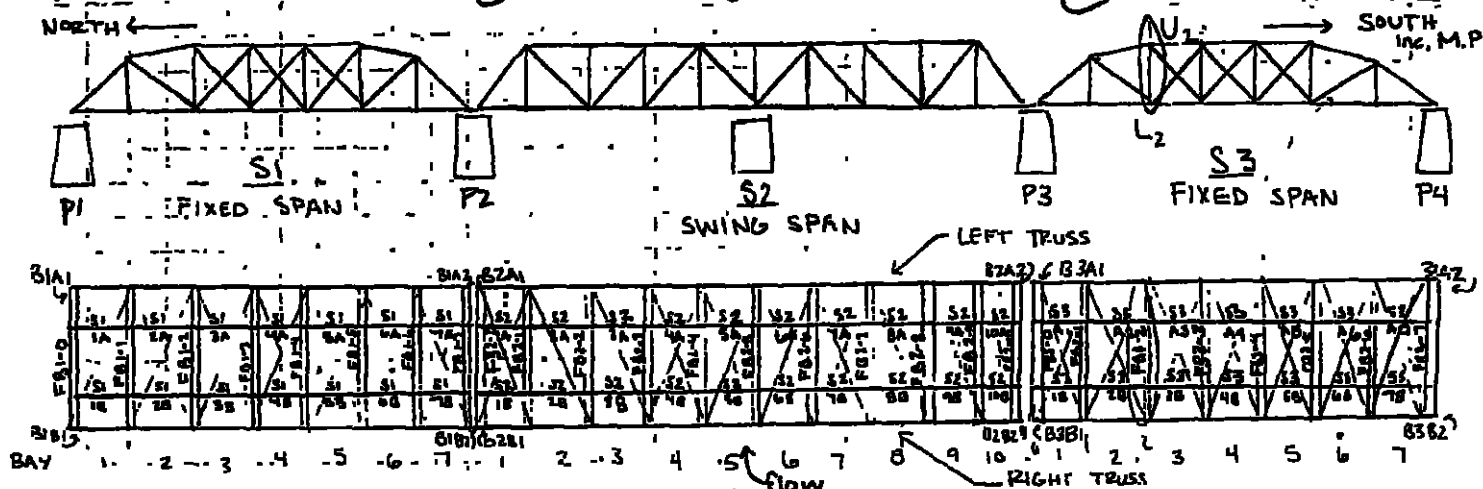
Location: Span 1 2 (3) Truss L (R) Member TC BC (MC) Bay: 2/3

NBI: 3 Condition: 5 Material Loss (%): 20  
Remarks: \_\_\_\_\_

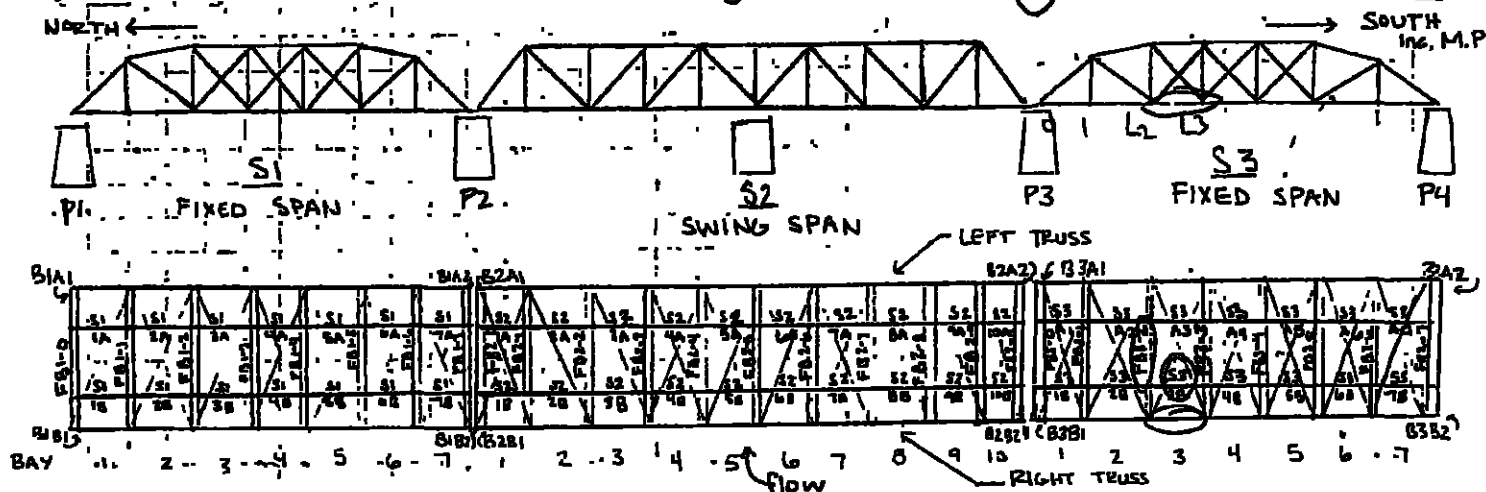
Location: Span 1 2 (3) Truss L (R) Member TC (BC) MC Bay: 3

Cross Brace: 1  
NBI: 2 Condition: 5 Material Loss (%): 90 (cross brace essentially does not exist.)  
Remarks:

Floor Beam: EA3-2  
NBI: 2 Condition: 5 Material Loss (%): 50 *hole in web*  
Remarks:

Stringer: 53.3B  
NBI: 2 Condition: 5 Material Loss (%): 4 *7/16 30 25 25*  
Remarks:

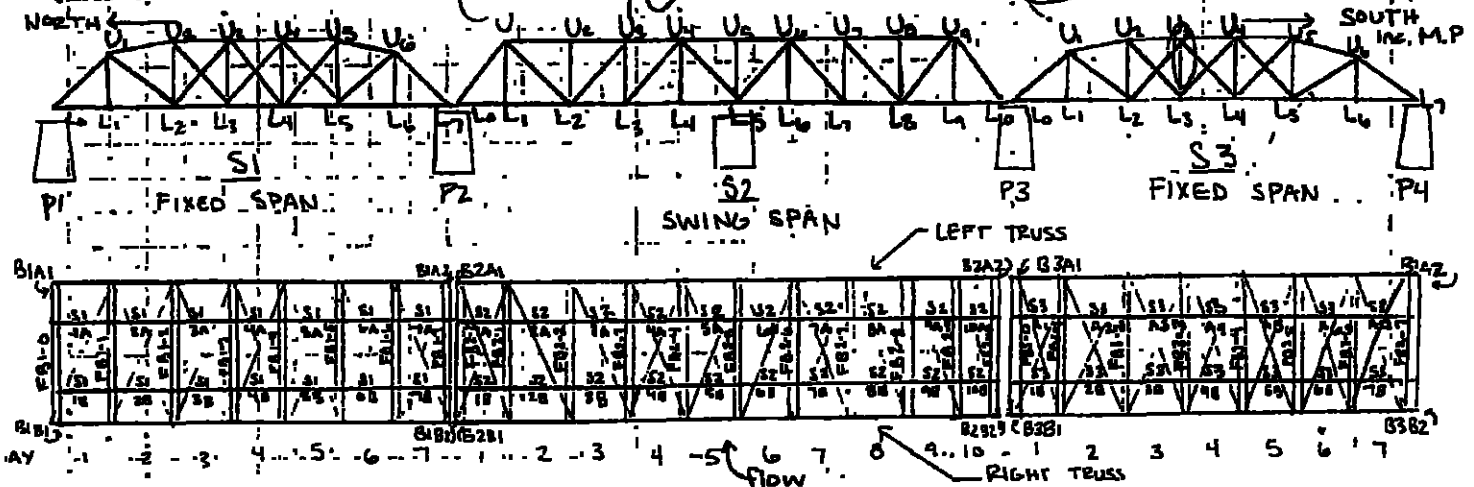
Bay: 4

| | Joint | Element | Joint | Remarks: |
|---|---|---|---|---|
| Condition Rating: | S | S | S | holes in member |

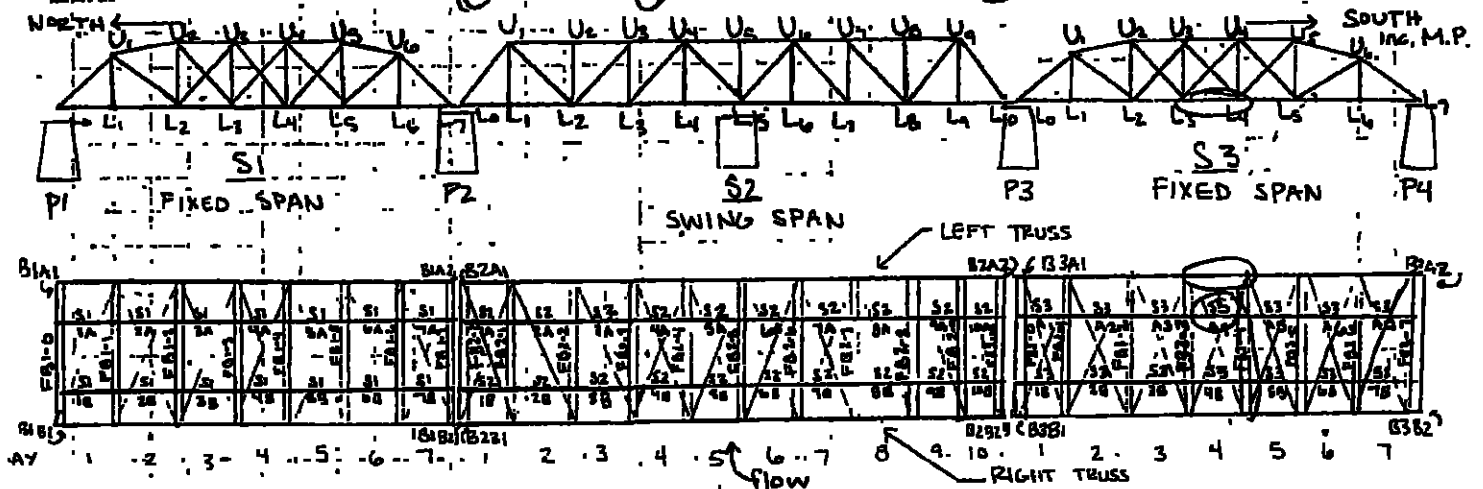
Location: Span 1 2 3 Truss 11 R Member TC BC MC Bay: 4

NBI: 1 Condition: 5 Material Loss (%): 75

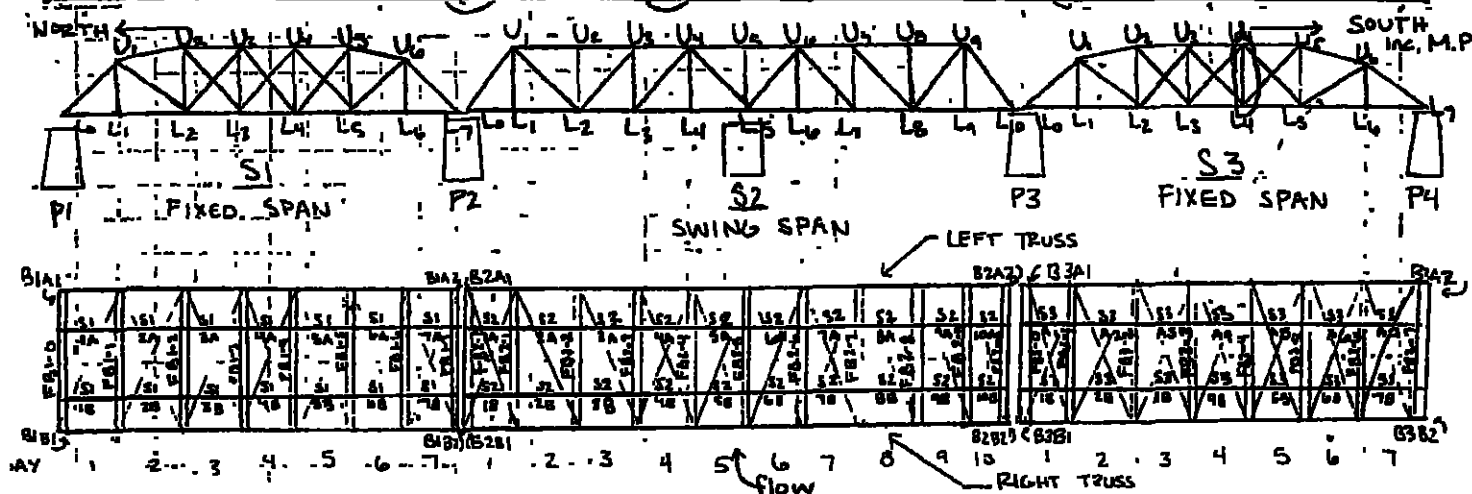
Location: Span 1 2(3) Truss (L), R Member TC BC (MC) Bay: 4

Upper Pin: \_\_\_\_\_  
NBI: \_\_\_\_\_ Condition: \_\_\_\_\_ Material Loss (%): \_\_\_\_\_ no access see S1 U4L4  
Remarks: \_\_\_\_\_

Lower Pin: L4  
NBI: 3 Condition: 5 Material Loss (%): \_\_\_\_\_  
Remarks: minor plate not

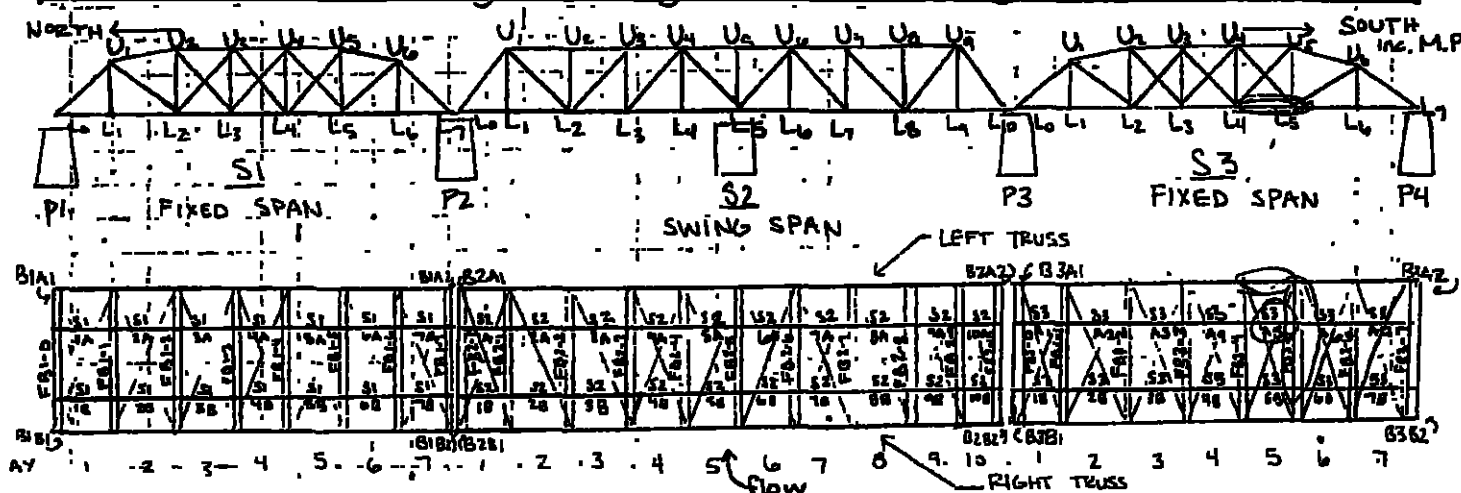
Location: Span 1 2 3 Truss (L) R Member TC (BC) MC Bay: S

| | Joint | Element | Joint | Remarks: |
|---|---|---|---|---|
| NBI-Rating: | 4 | 4 | 4 | laminar rot |

NBI: 2 Condition: 5 Material Loss (%): 50%

Remarks: holes, pack rot, holes

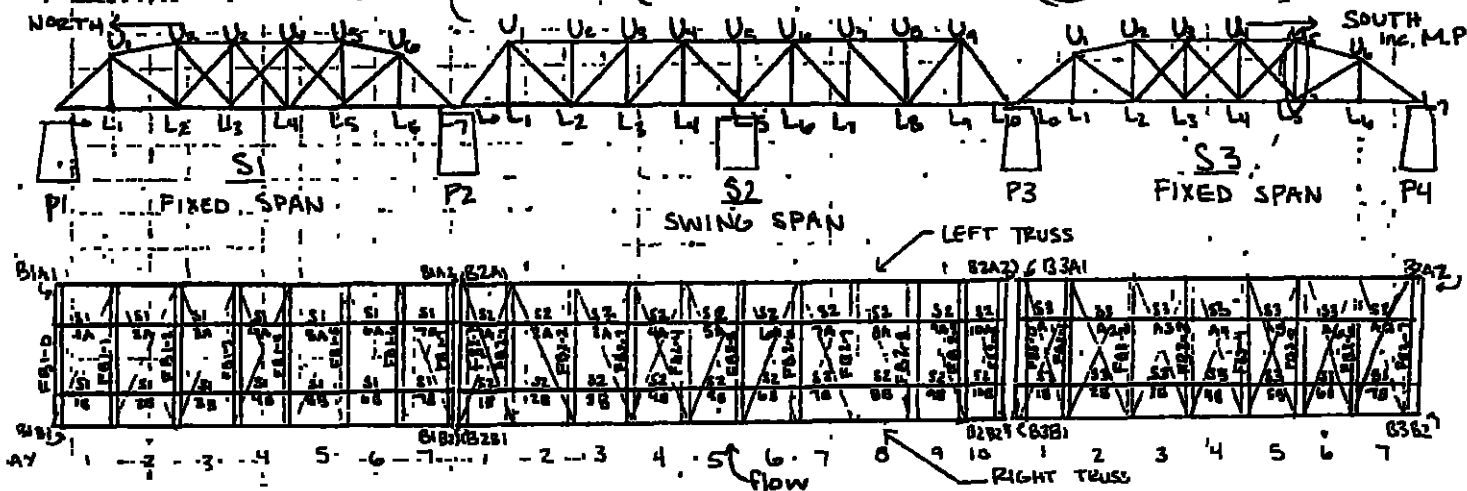
| Member Name: | Joint | Element | Joint | Remarks: |
|---|---|---|---|---|
| NBI Rating: | 3 | 3 | 3 | Some rivets have corroded out |

MOISTURE INTRUSION ON SPACER, MOD-HEAVY PACK NAIL

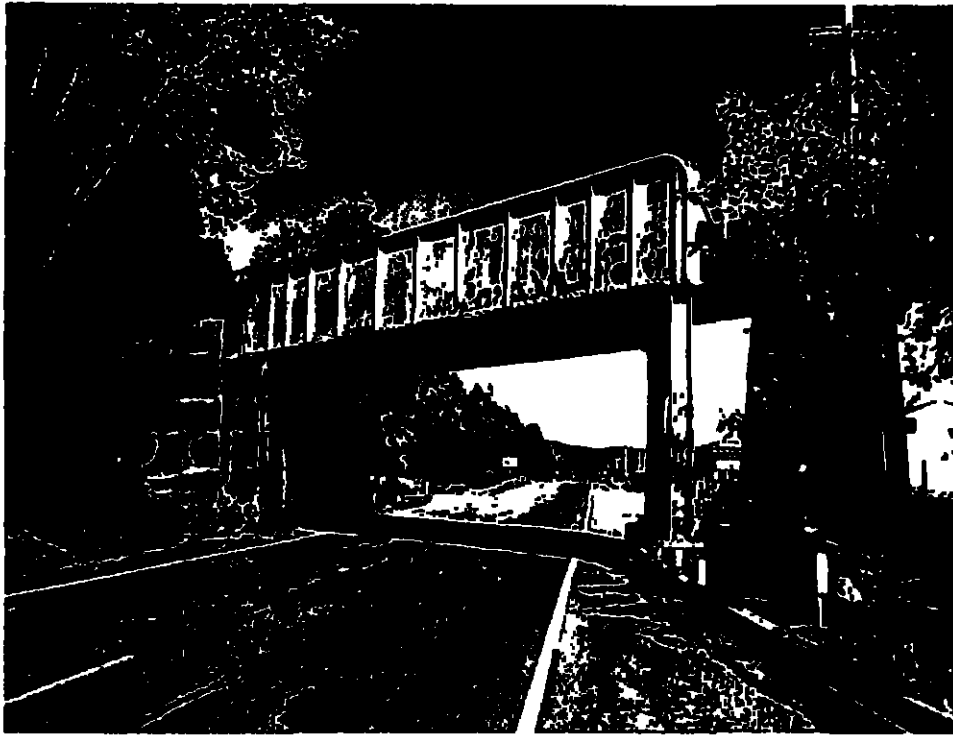
**Photo 1 Through Truss Overall View**

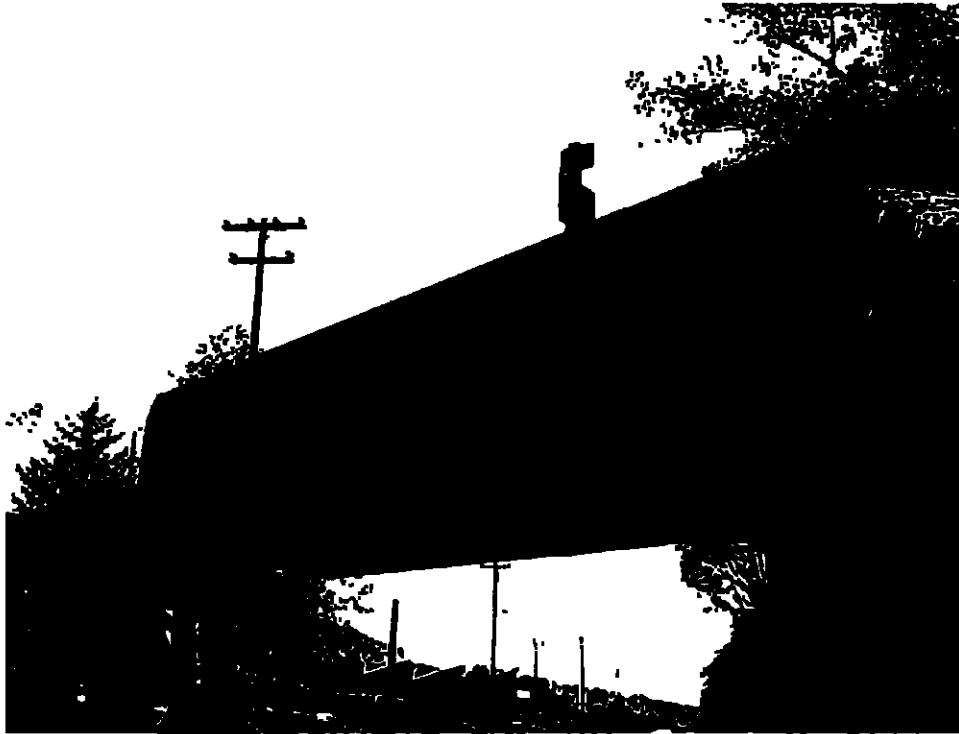
**Photo 7 Girder A**

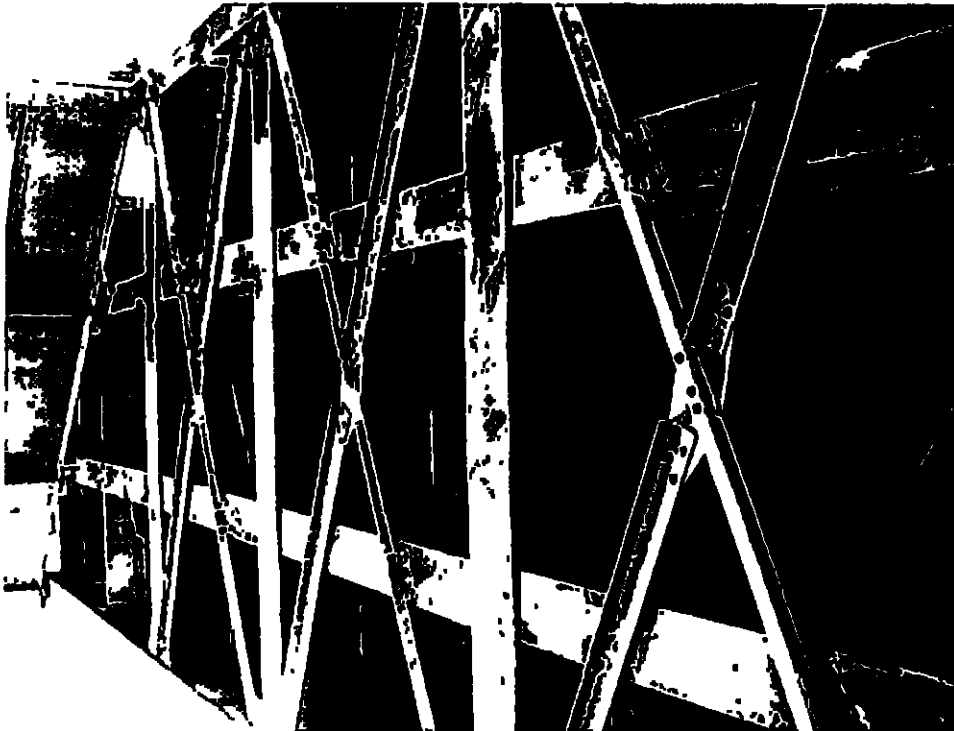
**Photo 9 Girder A- Bottom View**

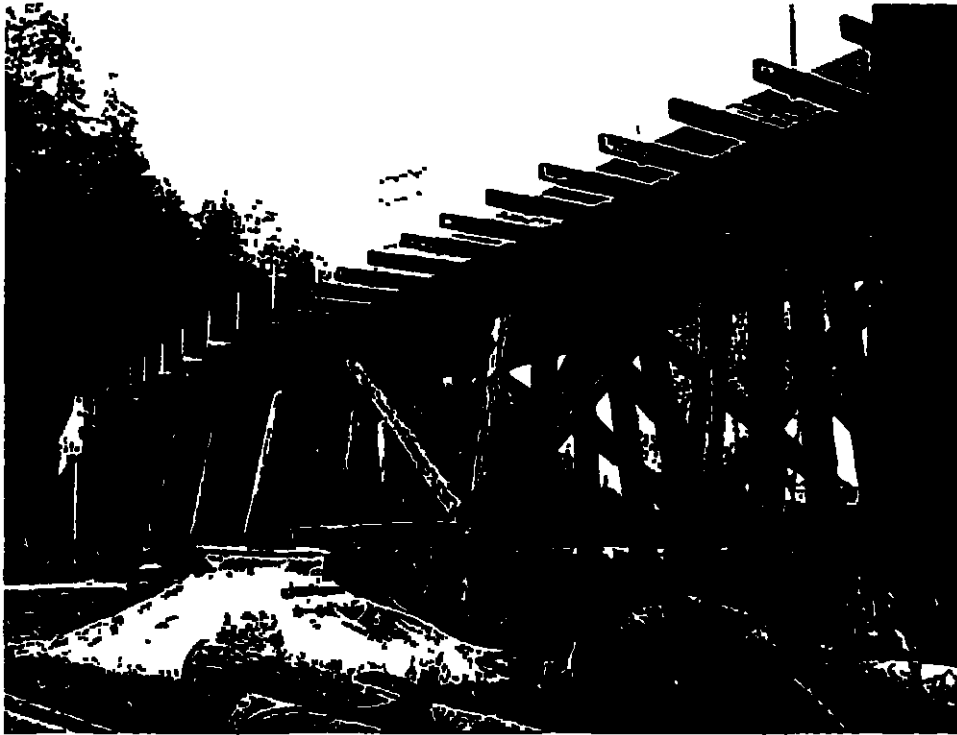
**Photo 10 Overall View**

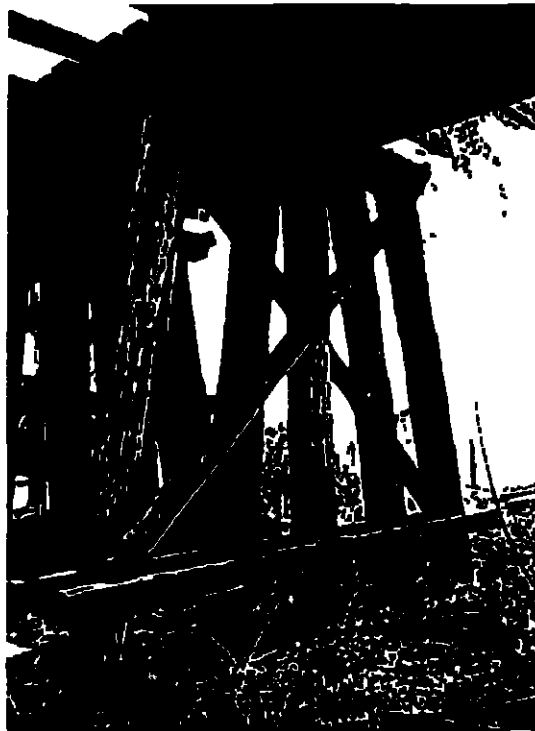
**Photo 13 Bent 3**

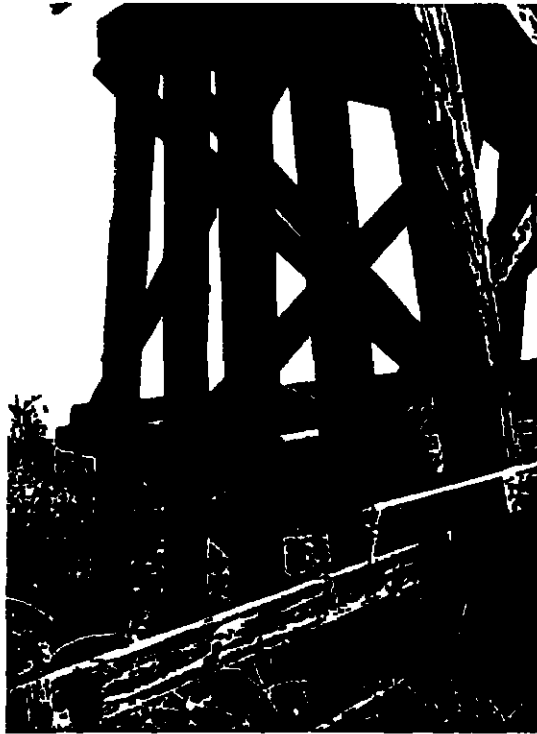
**Photo 16 Bent 6**

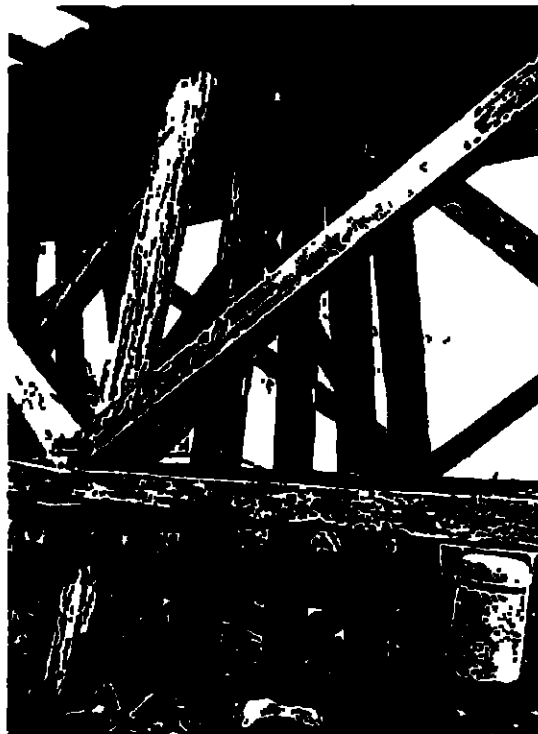
**Photo 17 Bent 7**
