**BEFORE THE  
SURFACE TRANSPORTATION BOARD**

FINANCE DOCKET 36609

**FOSTER POULTRY FARMS—**  
**EX PARTE PETITION FOR EMERGENCY SERVICE ORDER**

**NOTICE OF FILING**

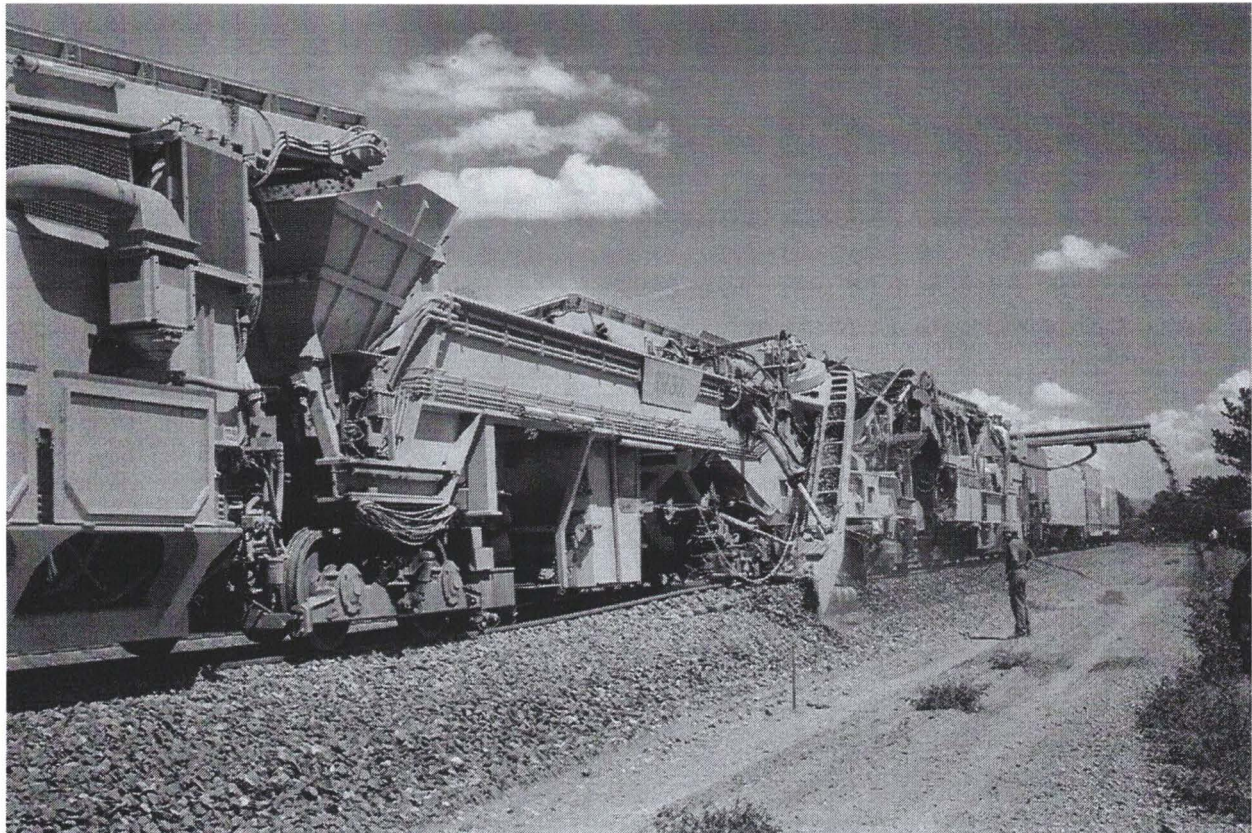
Two primary undercutting platform solutions are used to reestablish a more permeable ballast and a more substantial structure. The first is an undercutter cleaning system typically equipped with a track lifting and slewing mechanism that allows the track to be lifted to reduce the cutting depths and to be shifted laterally as required to clear trackside obstacles. A high-powered cutting chain is then positioned under the railroad ties. The cutting chain or sled removes all of the fouled ballast material using conveyer belts to move the degraded material to an inline ballast cleaning system allowing the larger cleaned ballast to be reclaimed. A slew able discharge conveyor takes the waste material to be discharged to either side of the right-of-way.

Maintenance of the ballast layer directly below the ties is essential to a healthy track structure. Ballast degrades over time and becomes increasingly fouled, reducing its ability to drain, provide adequate load-bearing support, and withstand vertical, lateral, and longitudinal forces. Undercutting is needed to restore the desired ballast properties after becoming fouled. Undercutting is the continuous excavation of the material beneath the ties. The material excavated can either be wasted or screened and returned to the track with only the fines being discarded or can leave the track skeletonized to allow for the dumping of a fresh ballast layer.
