February 15, 2008

Re: Comments on the Draft Scope of the EIS  
Village of Barrington Hills, Illinois

Surface Transportation Board  
CN-EJ&E EIS - FD-35087

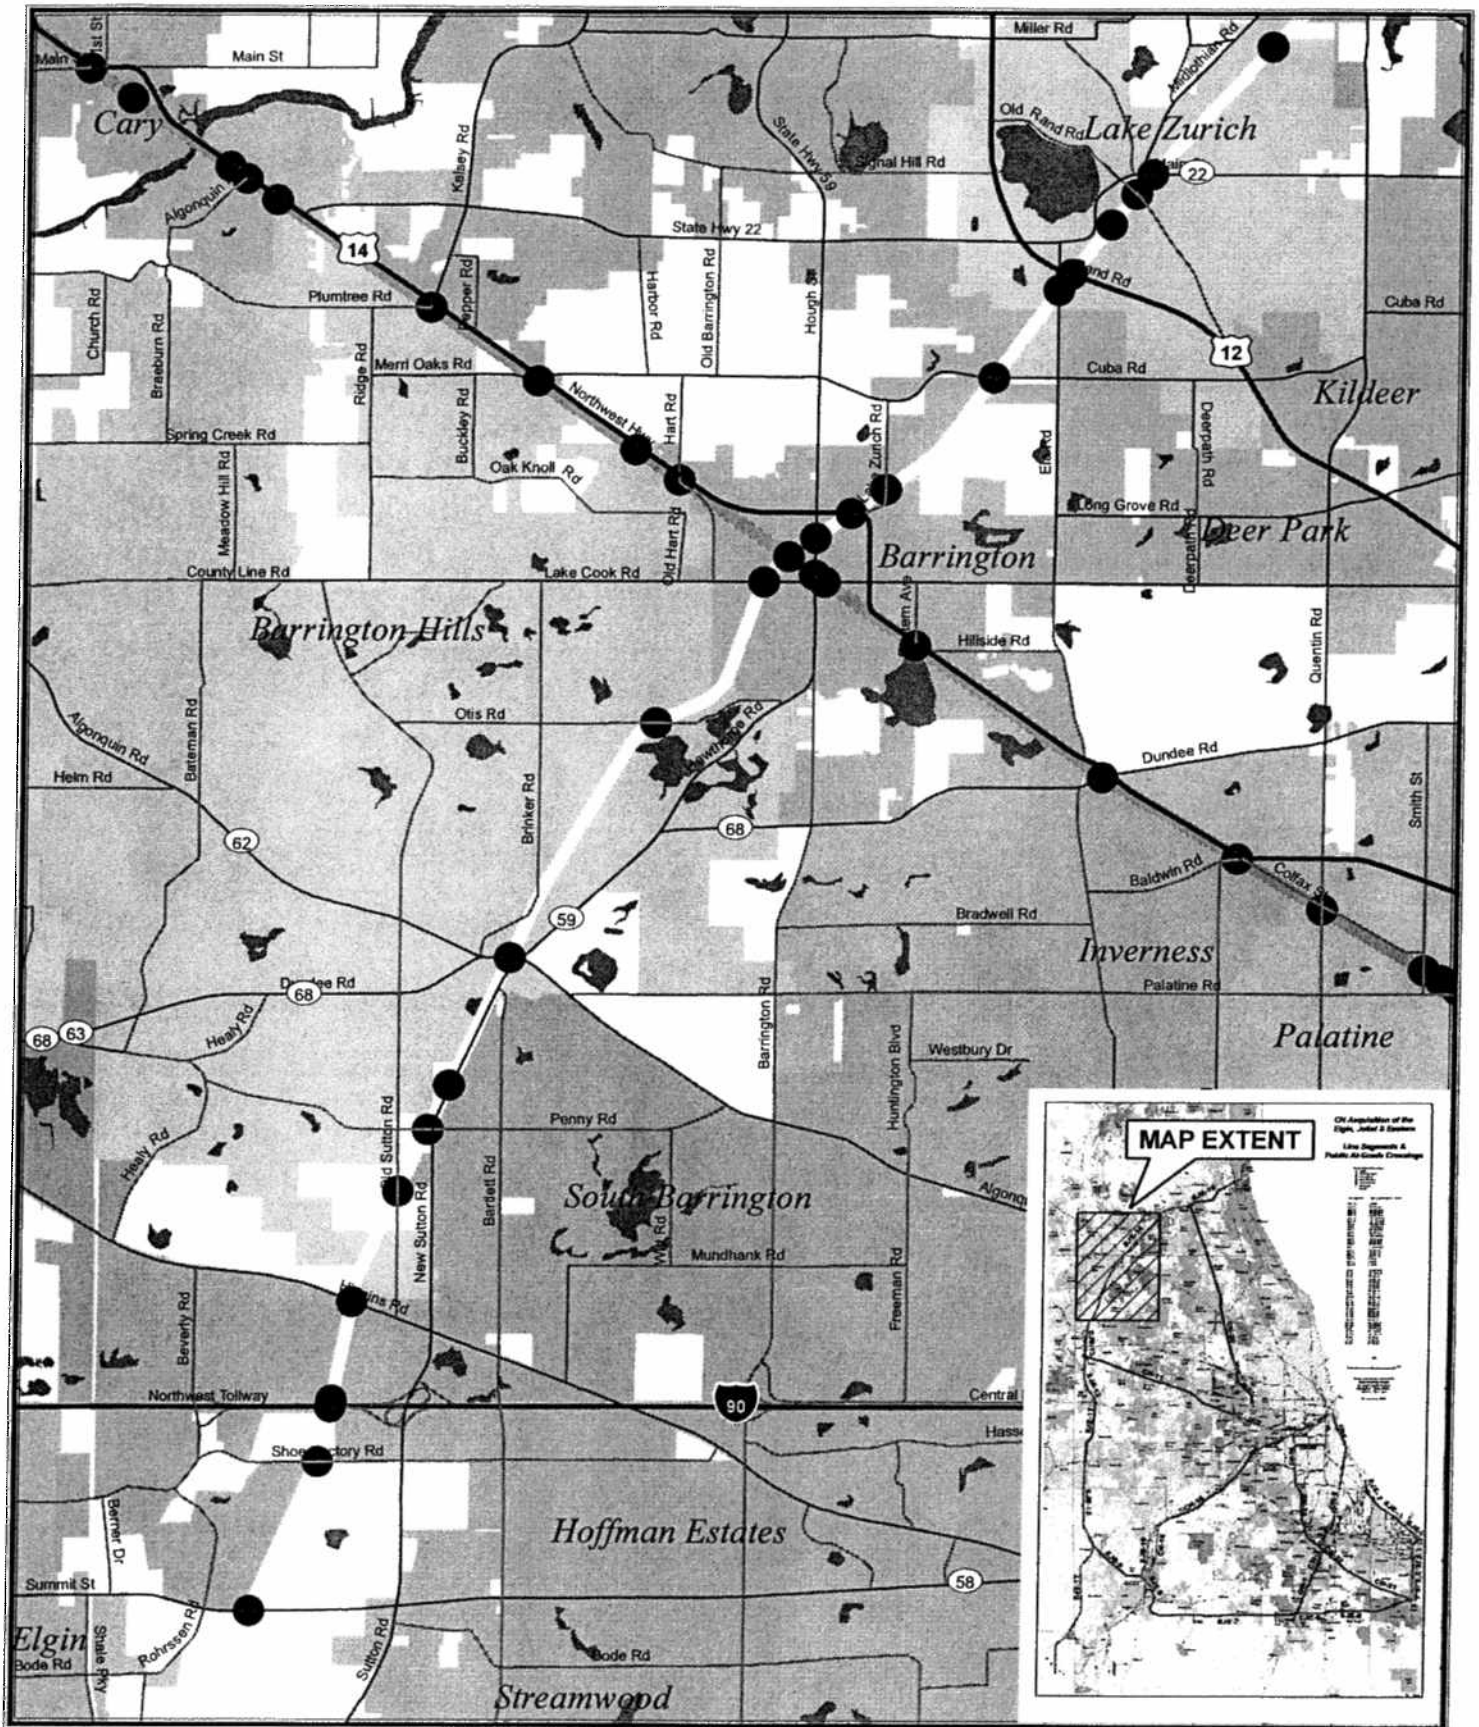
**Attachment B** provides a map showing the EJ&E rail as it passes through Barrington Hills, and surrounding communities.

- GRADE SEPARATED CROSSING
- AT GRADE CROSSING
- EJ&E RAILWAY
- UNION PACIFIC RAILWAY

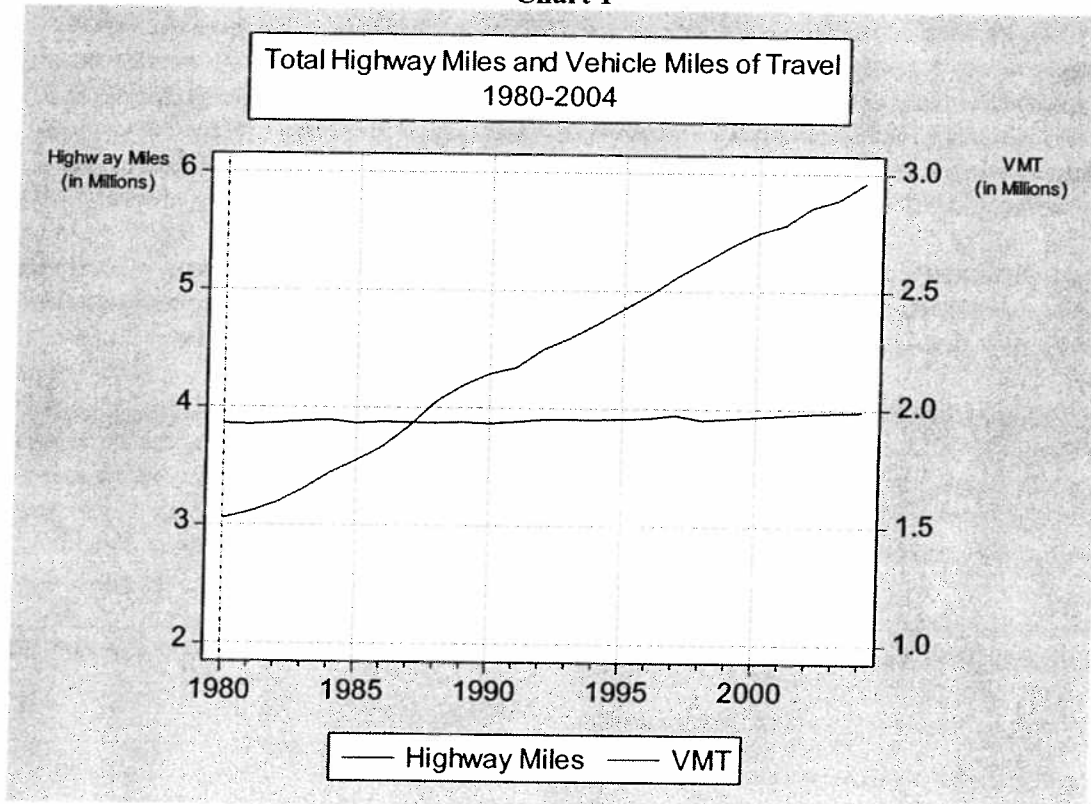
Highway traffic has grown steadily. As Chart 1 indicates, the number of lane miles has grown much more slowly. This has led to increased traffic density on many of our roads and highways. With more highway traffic, blocked crossings inevitably lead to more delays for motorists. The ensuing congestion can further hamper emergency responders who are delayed by a train in a crossing. They must then make their way through the traffic resulting from blocked crossing.

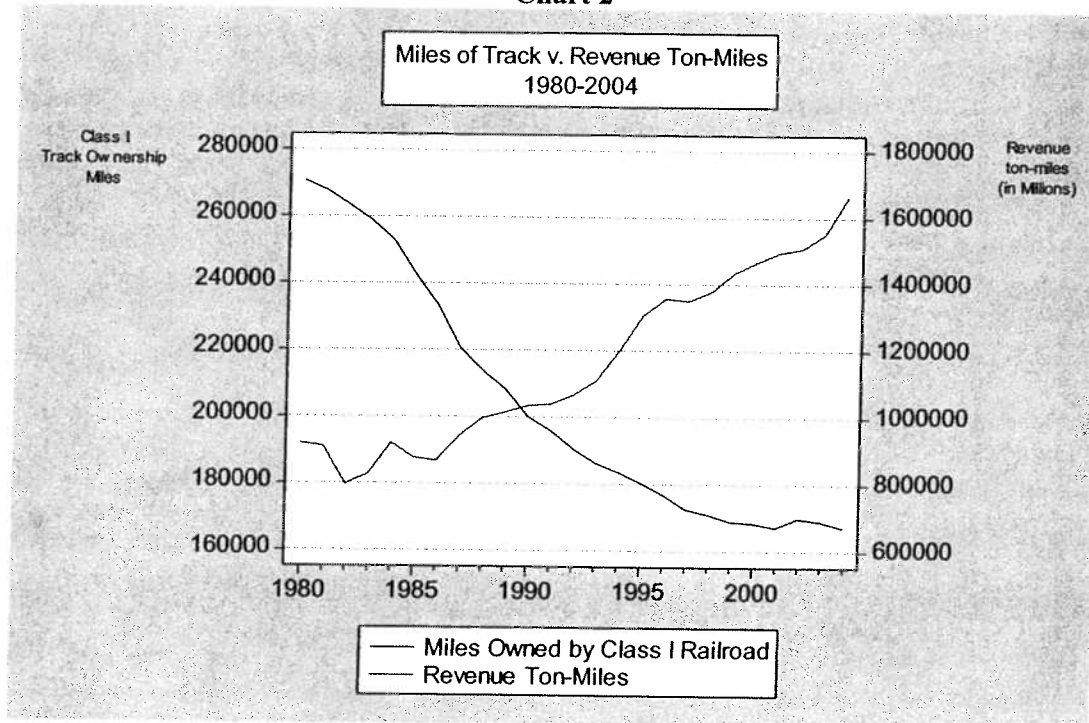
Chart 2

Between 1980 and 2004, despite traffic growth, railroad track miles decreased considerably (see Chart 2). The result is that density – cars or trains per day for each mile of highway or track - has steadily grown. Grade separations have alleviated conflicts in some areas, but more trains and more vehicles at most crossings inevitably lead to highway delays – delays that can also delay emergency response times.

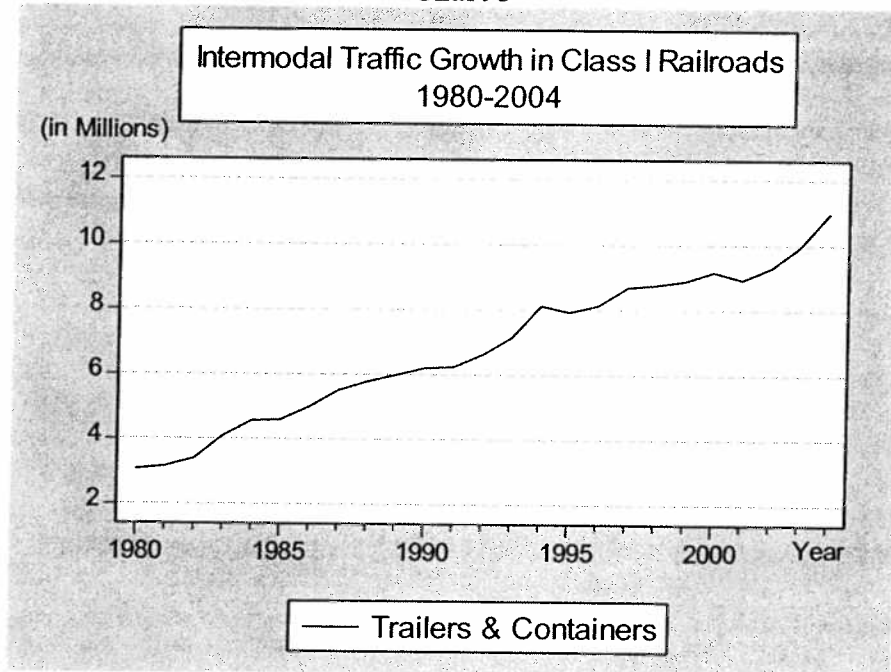
**Chart 3**

trains to and from the Ports of Los Angeles and Long Beach, has been phenomenal (see Chart 3). Coal traffic, the historic mainstay of the rail industry, has also been increasing rapidly. The relatively low price of coal for generating electricity, compared to natural gas and oil, has led many utilities to increase the use of coal where possible. Responding to legislation to reduce emissions, many utilities have switched to low-sulfur coal from the Powder River Basin in northeastern Wyoming and nearby areas. This coal is now being hauled to utilities in the south and east. These long hauls have increased traffic on a number of Midwestern rail lines.

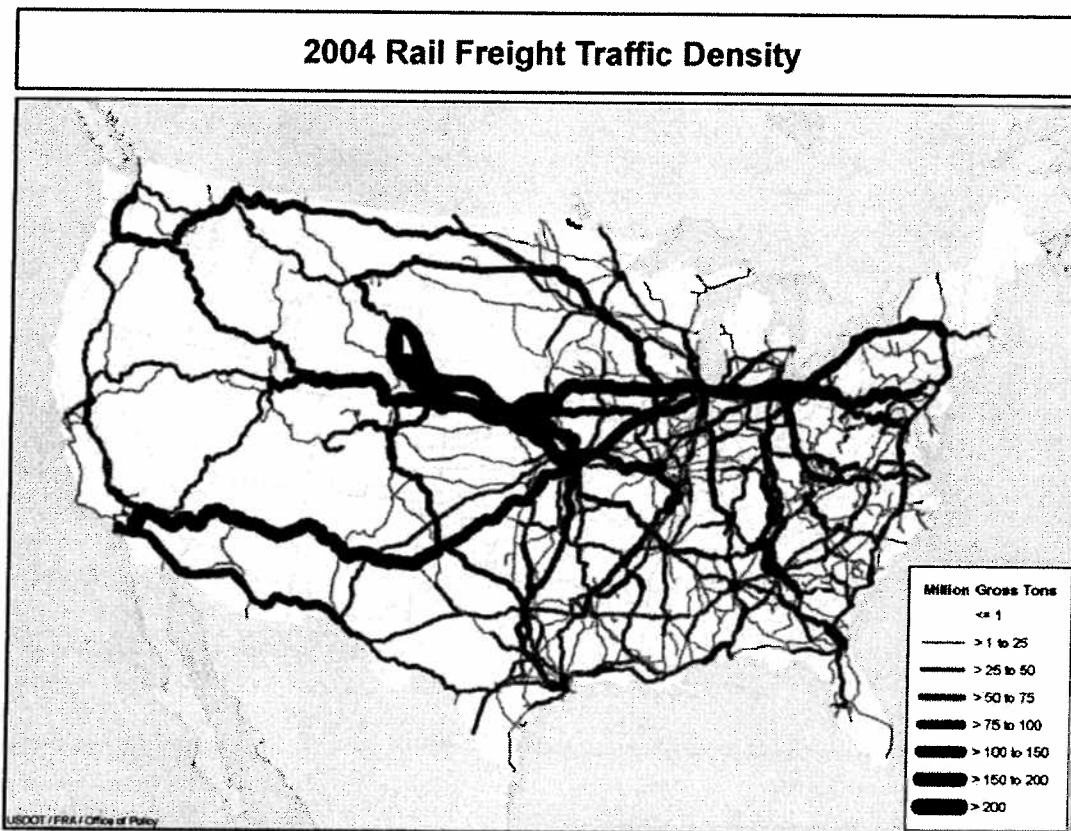
Map 1

Rail freight traffic density is shown in Map 1. Forecasts by the U.S. DOT and DRI-WEFA (see AASHTO Bottom Line Report, Table 6, Page 56) indicate that freight traffic overall is likely to increase 57% between 2000 and 2020 while rail traffic is forecast to grow by 44% in the same period, leading to even greater density.

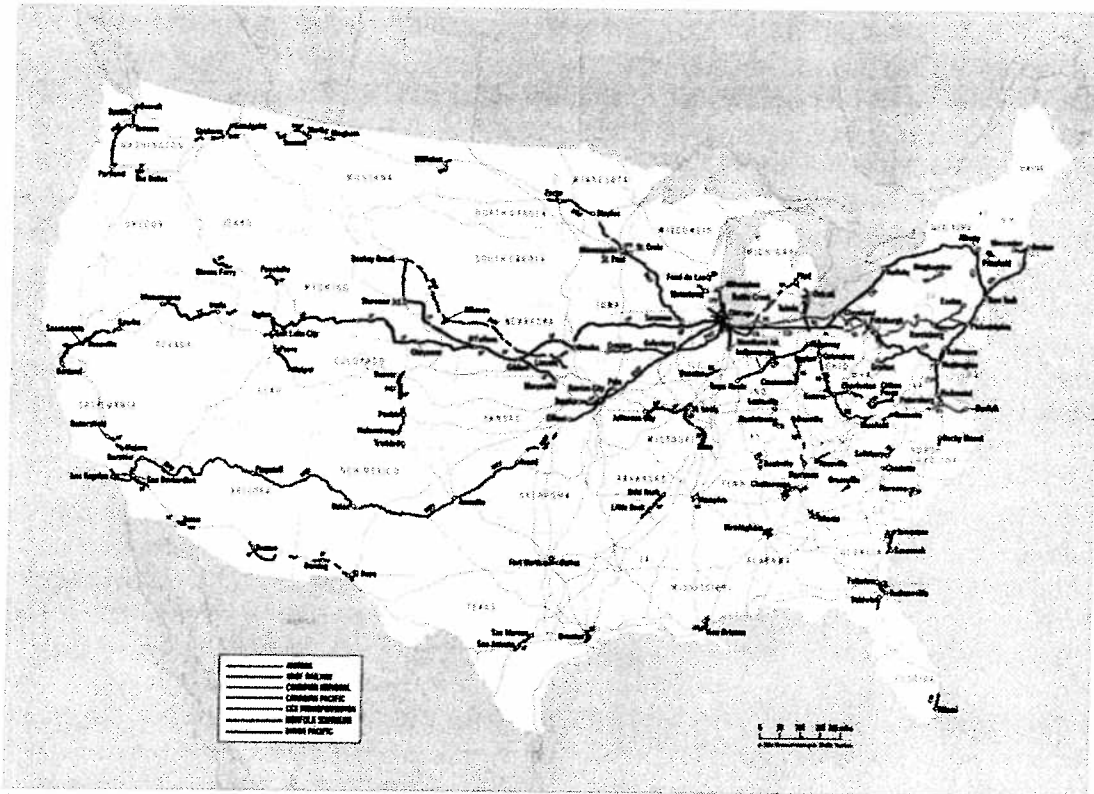
As the Map 2 shows, most railroad mainlines in the U.S. are single track. As traffic grows, a single-track railroad can quickly become congested, resulting in trains stopped in sidings for sometimes hours.

Colored lines indicate double (or more) tracked rail lines

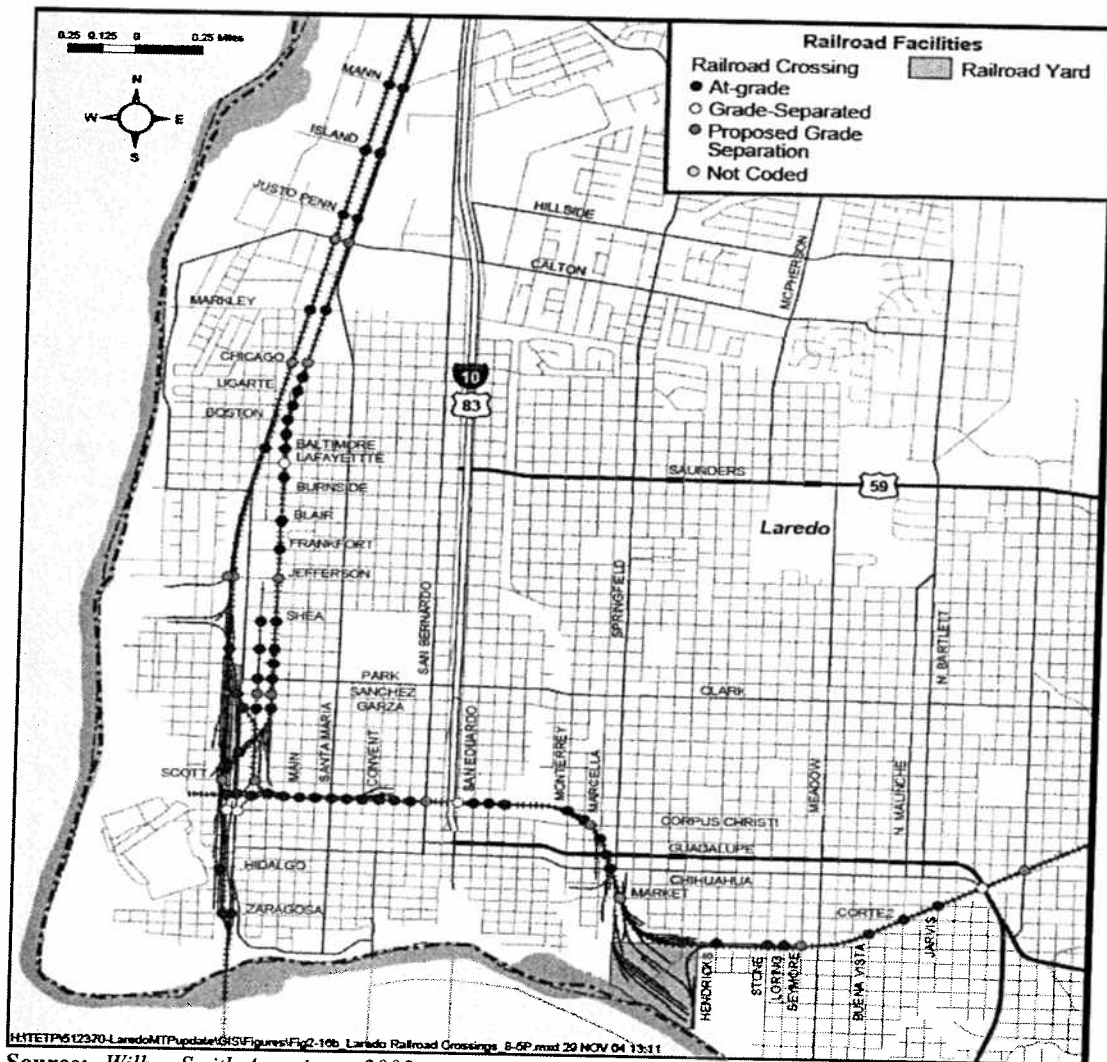
All US/Mexico traffic at Laredo uses the single-track international railroad bridge in downtown Laredo, which connects TFM with Texas-Mexican/KCS and UP. The bridge is owned by KCS but UP operates over the bridge via a usage agreement. The Texas-Mexican Railroad has an east-west direction and travels to Corpus Christi then to Houston and the Midwest. The UP connects north to its mainline in San Antonio. The railroads in downtown Laredo run parallel to the Rio Grande, the border with Mexico, resulting in a long and thin strip of urban land between the railroads and the border. Each company owns a rail yard where it sorts and assembles rail cars. The UP rail yard is located about a half mile north of the international bridge and is used primarily for import and export operations. The Texas-Mexican rail yard is located to the east in central Laredo, and is used to assemble trains going out to east Texas and the Midwest or Mexico. The two railroads combined have 81 grade crossings in Laredo, plus five grade separations. Map 2A (pg. 7) shows the location of the railroads and Laredo street system.

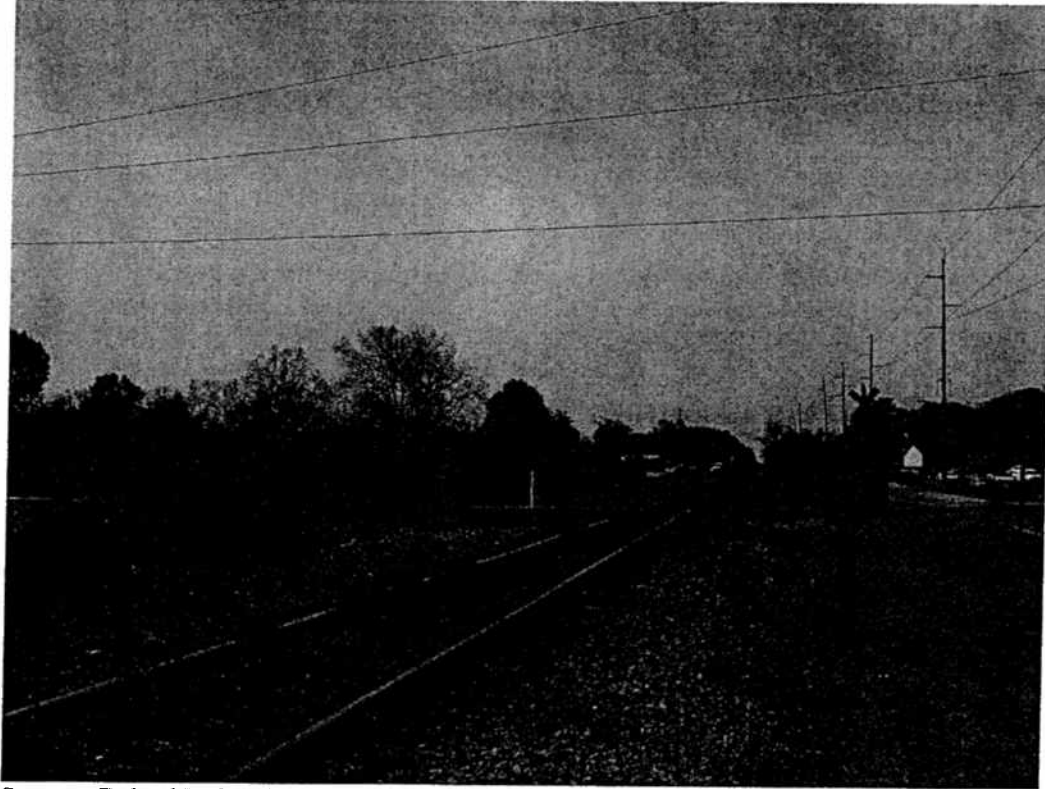
**Figure 1.** - CSX-NS railroad intersection

In Figure 1, the CSX track runs from the bottom left (south) and the NS line runs across the figure horizontally. Currently, CSX trains proceed past this crossing to a yard, where the locomotives are moved to the opposite end of the train, the new front of the train, and the train then uses the connecting track shown in Figure 4 to proceed eastward (left in this picture). A direct connecting track running to the left in Figure 1 between the CSX line and the NS line would eliminate blocked crossings caused by the need to move locomotives to the opposite end of the train.

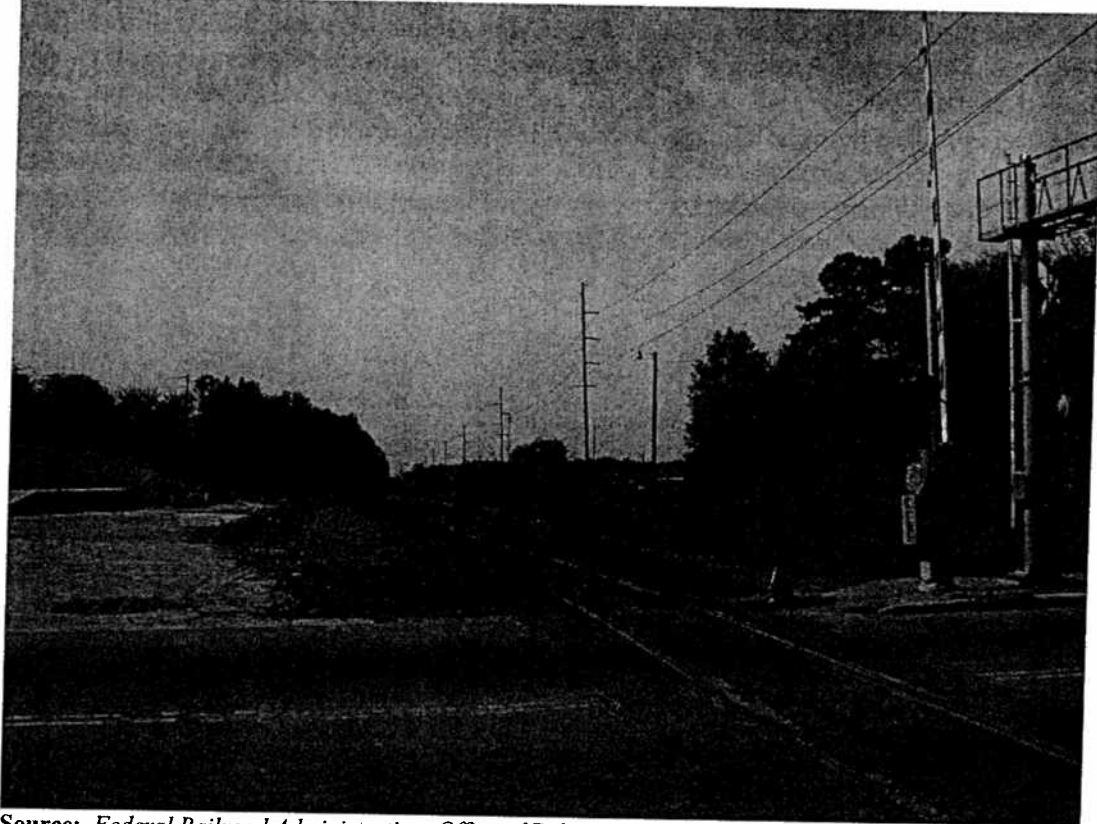
**Figure 2.** – CSX rail yard and Howell Street

Figure 2 illustrates the proximity of Howell Street to the north end of the CSX rail yard and how trains will likely block the crossing.

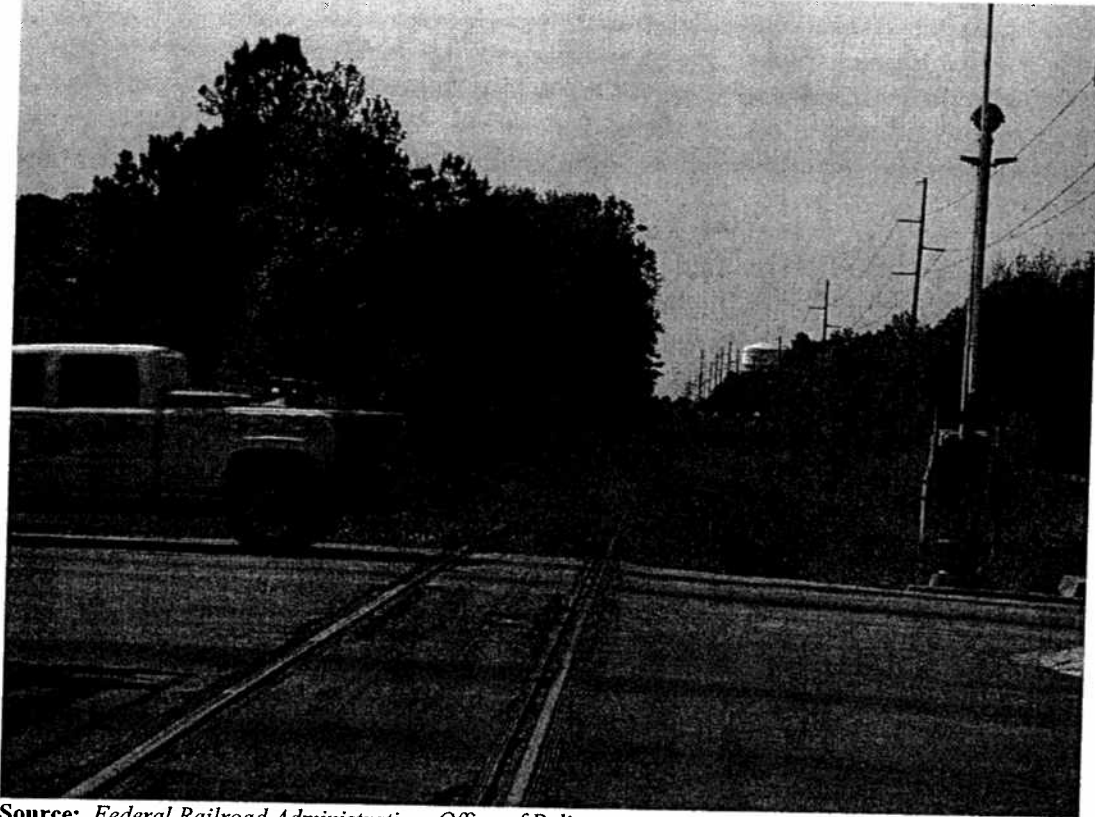
**Figure 3.-** At Grade Crossing of Arlington Boulevard & CSX railroad

Figure 3 above shows the at-grade crossing of Arlington Boulevard and the CSX Transportation rail line. Arlington Boulevard is at the southern limit of the yard. This artery serves as access road for a high school, located next to the yard. To the left of the picture is a residential area and people travel to the right to get to school, work and, if needed, medical services.

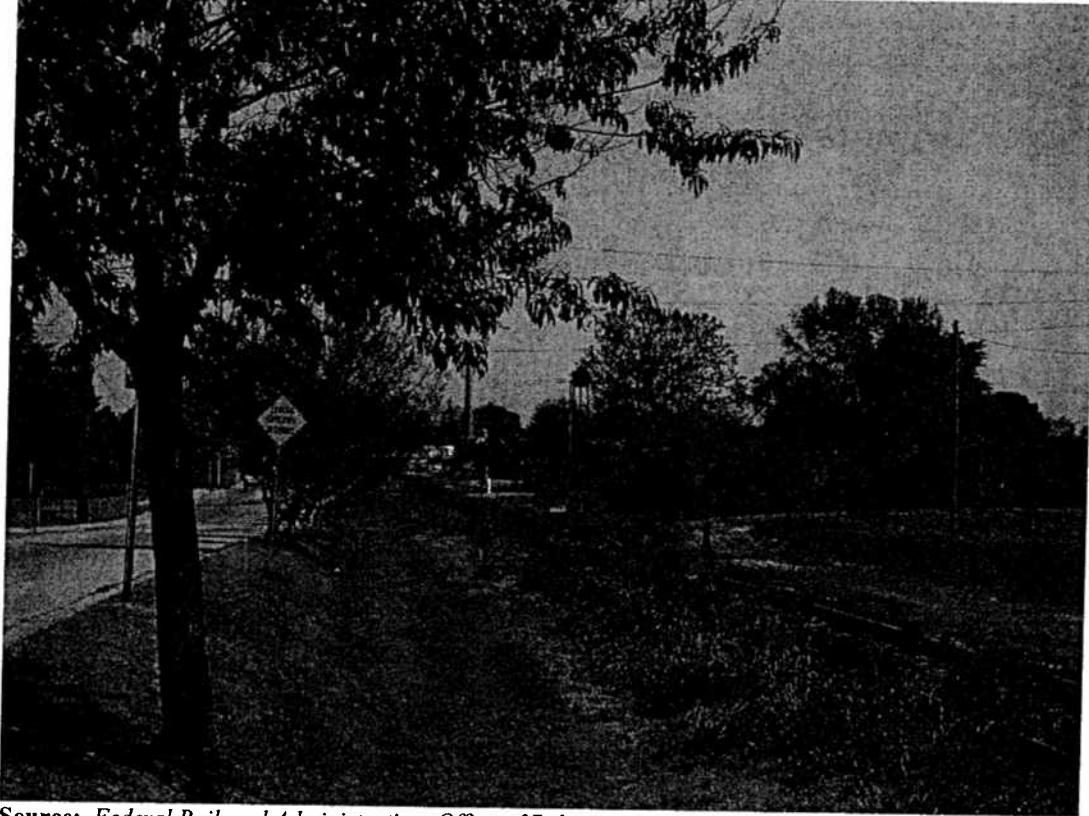
**Figure 4. - Northeast connecting track branching to the left**

Figure 4 faces north and shows the CSX line and the track heading off to the right that connects directly with the NS line to the east. The intersection of the two lines can be seen in the center of the picture. (Figure 1 was taken on the other side of the crossing in the center, looking south.)

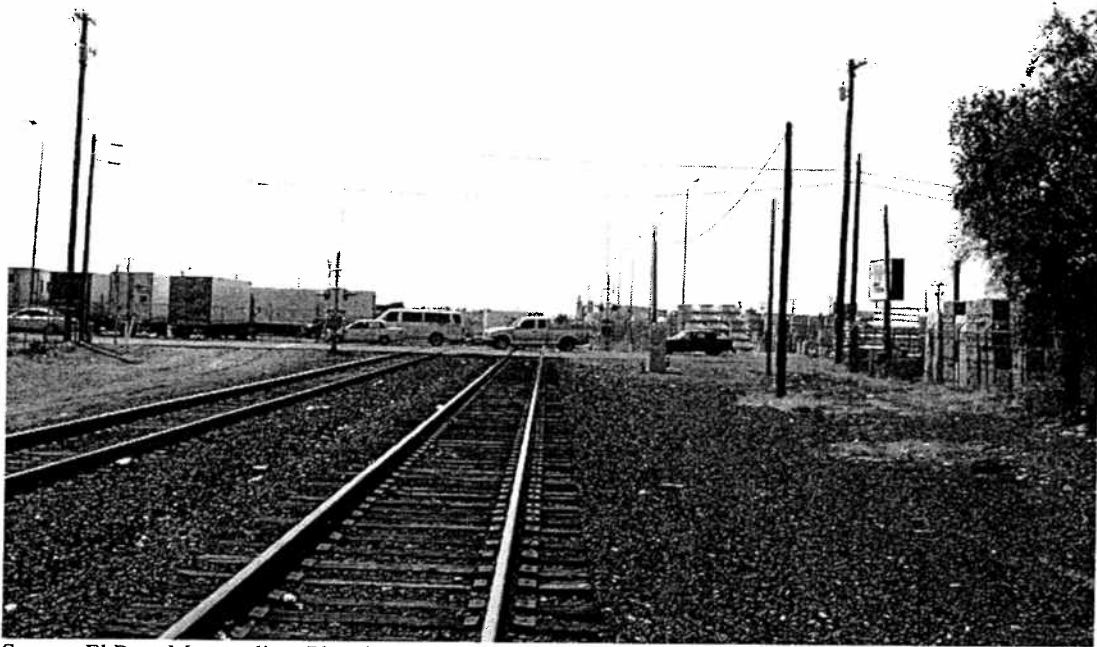
**Figure 1F. - Sunset Route and Zaragoza Rd. in El Paso, Texas**

The picture above shows the Sunset Route Zaragoza Road at-grade crossing. The El Paso MPO considers that this crossing presents a problem for effective emergency response. The railroad is between a major entertainment center and the regional command center of that area. An officer from the El Paso Police Department reported an incident when he was struggling to contain a brawl at the Speaking Rock Casino and, as the incident involved multiple individuals, he requested support from the police central command. At the moment when the other police cars were on their way to the nightclub to help their colleague, a train blocked the Zaragoza Road crossing which prevented the needed support to reach the scene immediately. Once at the blocked crossing, it would take longer to do a U-turn and go through the nearest separated grade crossing, thus, police cars decided to wait. The blockade lasted only for a few minutes and reinforcements eventually arrived at the incident location without serious consequences to the first officer on the scene. However, these types of incidents have the possibility of tragic results because they require immediate response. Medical services face the same type of problems in this area as most hospitals and providers are adjacent to I-10. Residents near Zaragoza Road must travel north to arrive to the closest hospital and face the same problem as the police department did in the example.

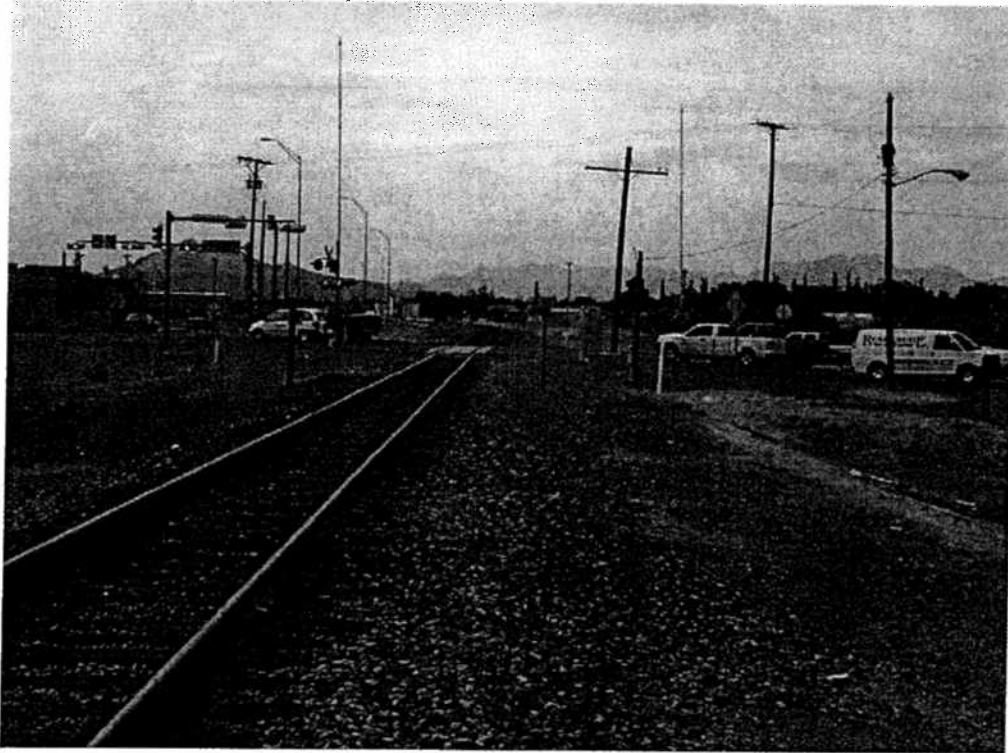
**Figure 2F. – BNSF railway in El Paso, Texas**

Doniphan Road runs parallel to the BNSF rail line. Local streets intersecting Doniphan also intersect the railroad. This causes problems as cross traffic may be stopped by traffic lights at Doniphan Road and then again at the grade crossing. Emergency responders are delayed when trains are in the crossings, especially those trains conducting switching operations. Blocked crossings are an issue because the zone to the west of the railroad is
